Whychus Creek Restoration Project at Camp Polk Meadow Preserve

June 29, 2007

A collaborative project of the:
**Upper Deschutes Watershed Council
Deschutes Basin Land Trust
Deschutes National Forest**

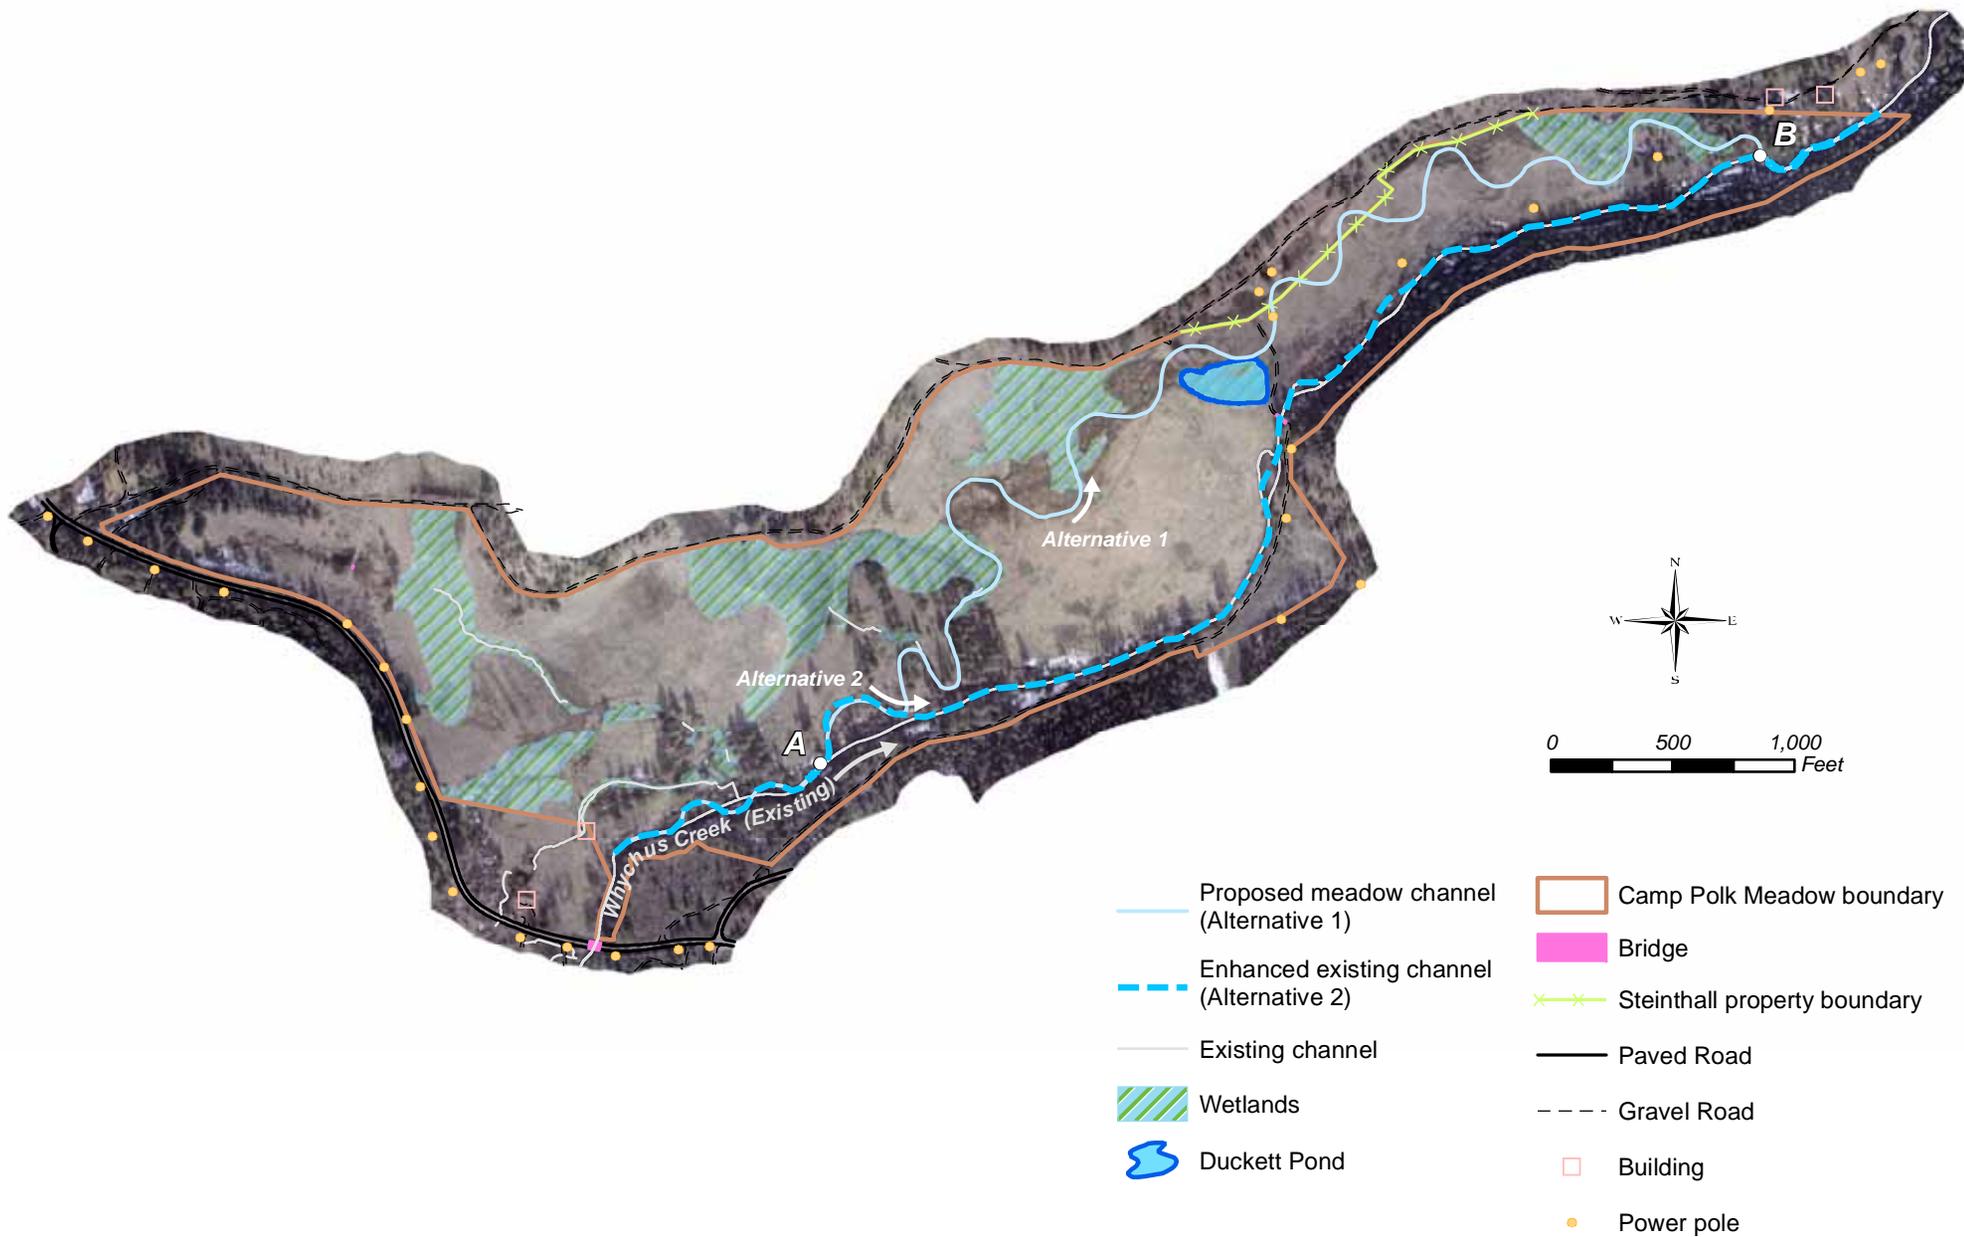
Figure 2.
Restoration alternatives.

Alternative 2 (Enhanced Existing Channel) would include developing additional meanders within the current alignment where feasible, constructing structures within the bed to develop and maintain pool habitat, and constructing lateral log complexes for habitat and hydrologic complexity. Due to the degree of entrenchment, meander opportunities are limited without creating a great deal of bank instability and, therefore, a much less sinuous channel would be

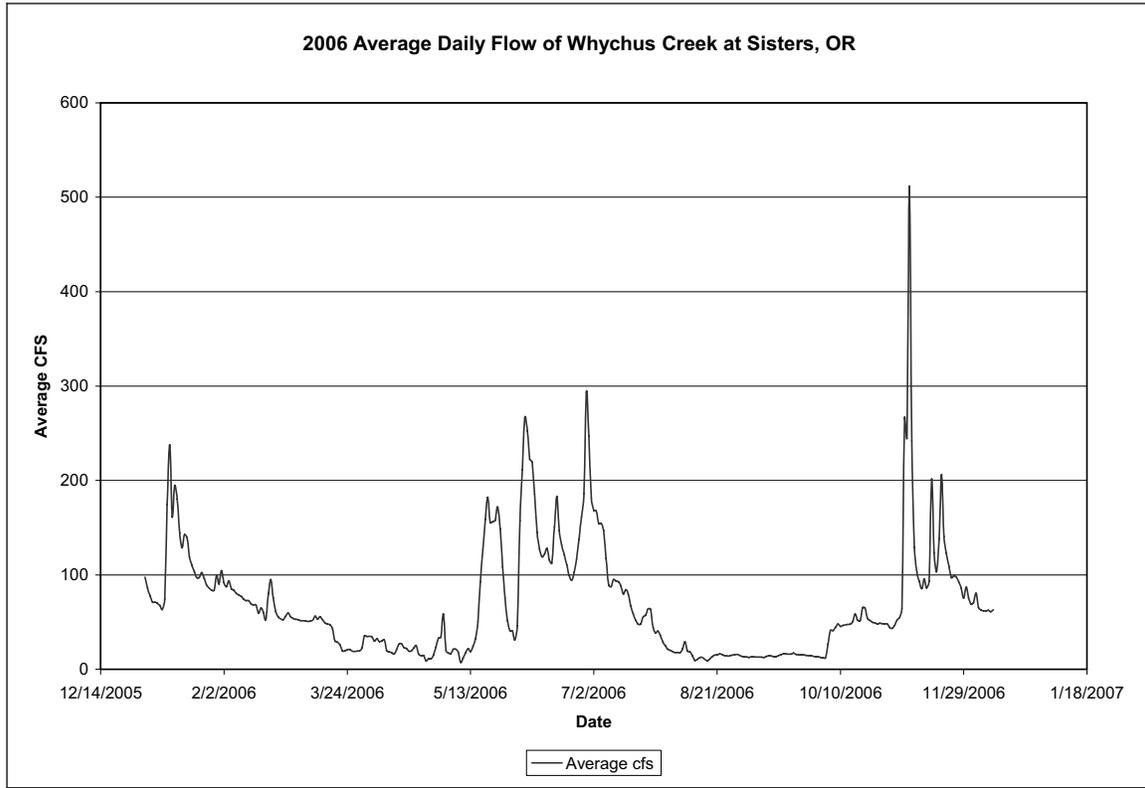
Figure 3. 2006 average daily flow of Whychus Creek. Flow data collected at Sisters, Oregon (#14076050).

The typical hydrograph for Whychus Creek both above and below the Three Creeks Irrigation Diversion is bimodal and flashy (**Figure 3**). Large, short duration rain-on-snow events occur during winter months and lower magnitude, more sustained elevated flows resulting from upland snowmelt occur during the spring months. Within the past 100 years, flows have fluctuated from 2,000 cfs during rain-on-snow events (1964) to zero cfs during summer months when 100% of the instream water was diverted for irrigation purposes.

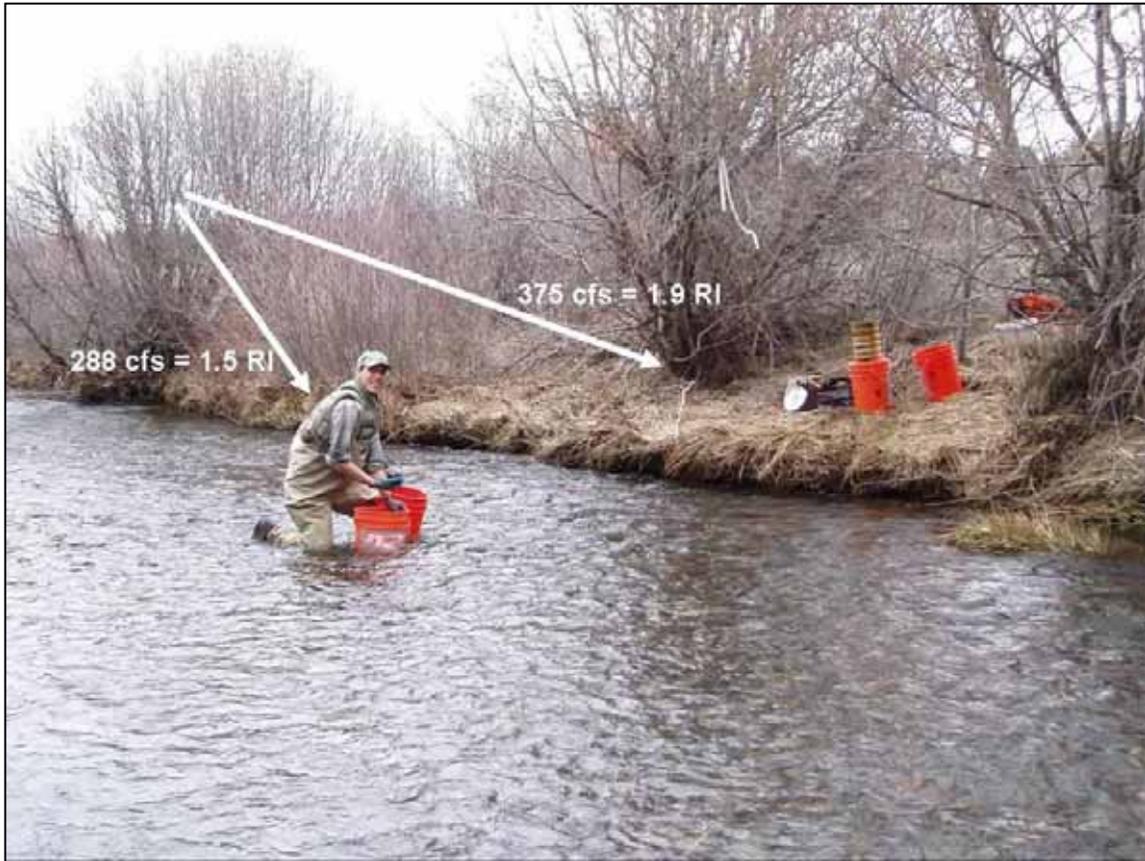
Figure 4. Photo of Whychus Creek at Cyrus property. This photo shows the bimodal indicators with an upper break and a lower terrace which likely has formed at spring snow melt discharges.

The effects of the bimodal discharge regime are most pronounced downstream of the Three Sisters Irrigation District Diversion. Indicators of the bimodal discharge are displayed on the ground in the form of cross sectional dimension and vegetative structure. At Camp Polk Meadow and on the Cyrus property (immediately upstream of Camp Polk Road) there is a grade break and larger sized alder indicator at an elevation that fits the RI of 1.9 and calculated discharge of 375 cfs. There is also a lower elevation grade break and smaller willow/alder line that correlates with a RI of 1.5 and a discharge of 288 cfs (**Figure 4**).

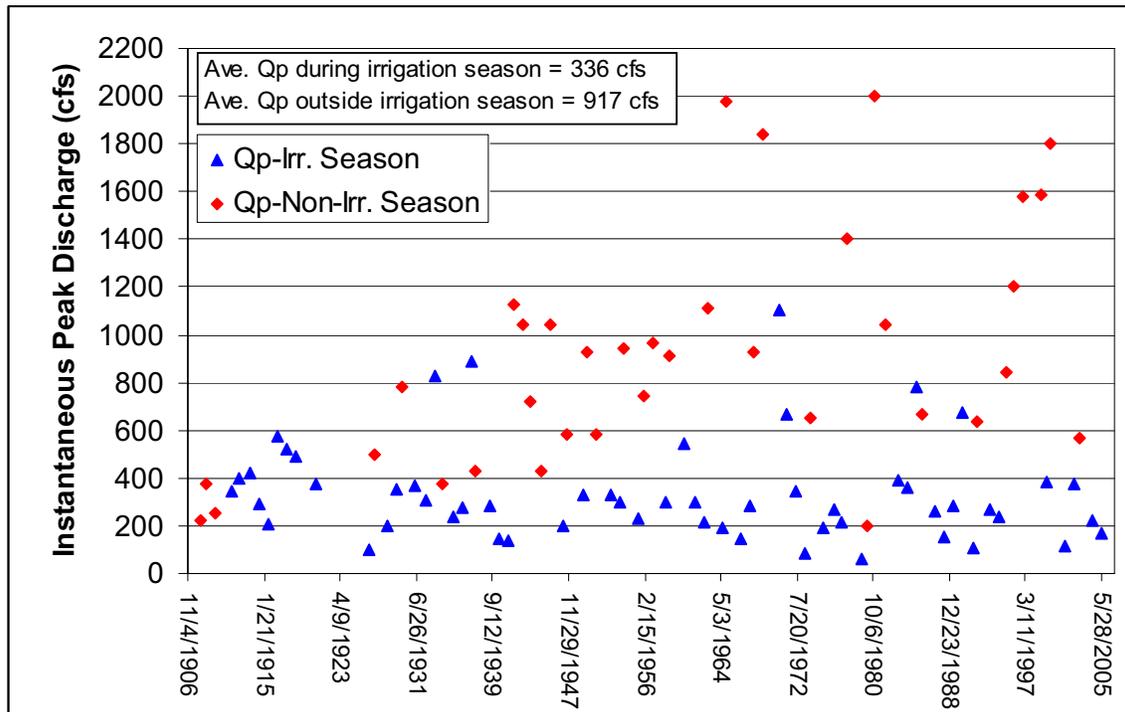
Figure 5. Annual instantaneous peak discharges, 1909-1994. Flow gauge located downstream of primary diversion. Red diamonds indicate peak flow for the water year occurring outside the irrigation season (October through March) while blue triangles indicate a peak flow that occurred during the irrigation season (April through September). Note the consistency of snow melt flows (blue triangles).

The average instantaneous peak occurring outside of the irrigation season (rain-on-snow) was 917 cfs as compared to the average of approximately 336 cfs occurring during the irrigation season (snow melt/summer thunderstorm) (**Figure 5**). In addition to the reductions in peak flow caused by the upstream irrigation diversion, summer base flows are significantly reduced as well. Summer low flow in Whychus Creek at Camp Polk Meadow is generally approximately 15 cfs, which is considerably more than in the past. In recent years conservation efforts

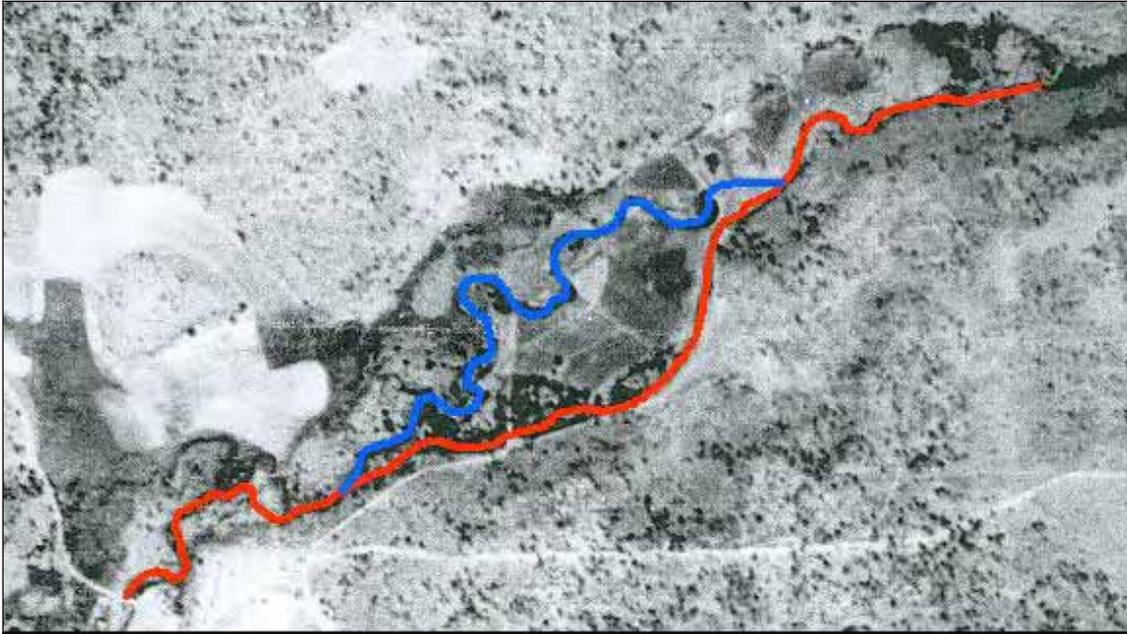
Figure 7. 1943 aerial photo (showing modifications). The main channel is shown in red and the old channel alignment in blue. The old channel is being used as an irrigation feed line.

In the 1943 photo, it is evident that Whychus Creek had already been pushed to the side of the valley and that relic meadow channel was being used as an irrigation canal to fill the Duckett Pond in the middle of the meadow (**Figure 6**; **Figure 7**). Based on the 1943 air photo, a survey cap dated 1938 in a relic channel, and the age of conifers within the bankfull elevation of the relic channel (80-85 years), it appears that Whychus Creek had probably been moved to the edge of the meadow prior to the 1930s.

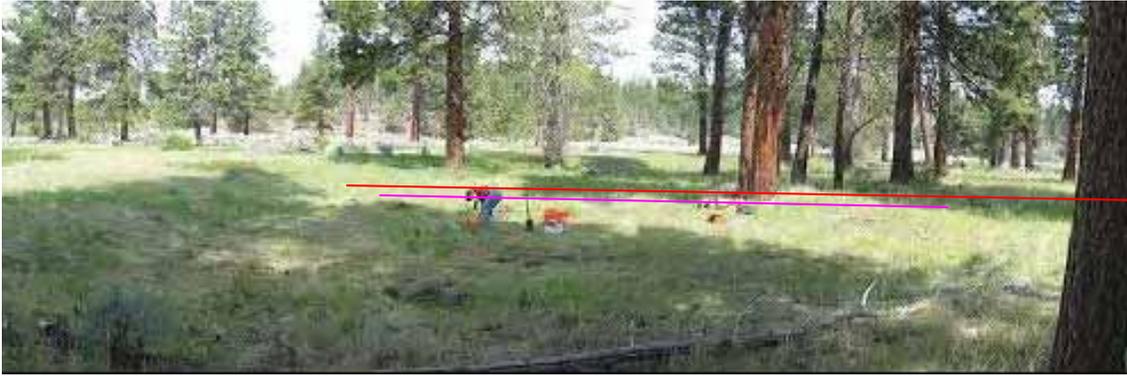
Figure 9. Downstream view of cross section #1 in the relic channel. The red line indicates the calculated area occupied by a discharge of 375 cfs (1.9 RI) with soil excavated to native bed material; pink line marks a discharge of 288 cfs (1.5 RI)

Three cross-sections and a longitudinal profile were surveyed in the relic channel to determine if it would be entrenched under the current flow regime (**Figure 8**, **Figure 9**). Historic streambed elevations were determined by excavating pits to the old streambed and then surveying the substrate bed elevation. Based on these surveys, the relic channel (where visible) is not entrenched and was used as a reference for some parameters of the designed meadow channel.

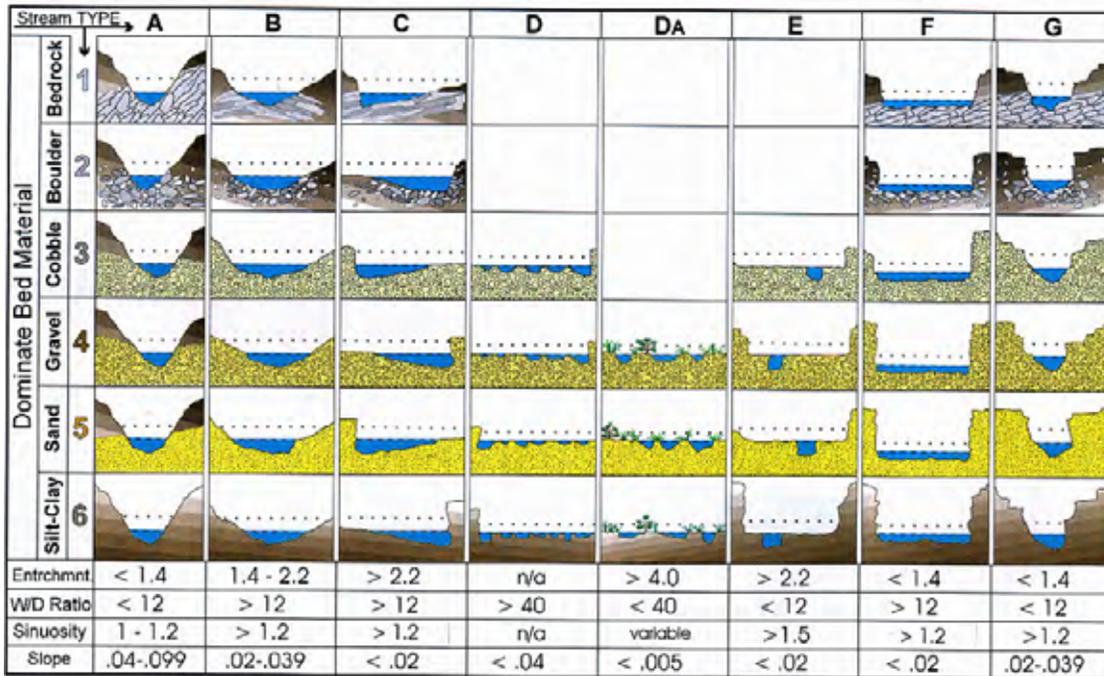
Figure 10. Delineative criteria and characteristics for the major stream types (Rosgen and Silvey 1996).

Whychus Creek has been in this condition for several decades, and despite generally poor habitat conditions, the stream has stabilized. There is one exception, found approximately midway through the property. At this site a sediment wedge has formed upstream of a footbridge. Lateral instability at this site has resulted in erosion of the left bank. The current stream condition exhibits B, C and F channel type characteristics (**Figure 10**).

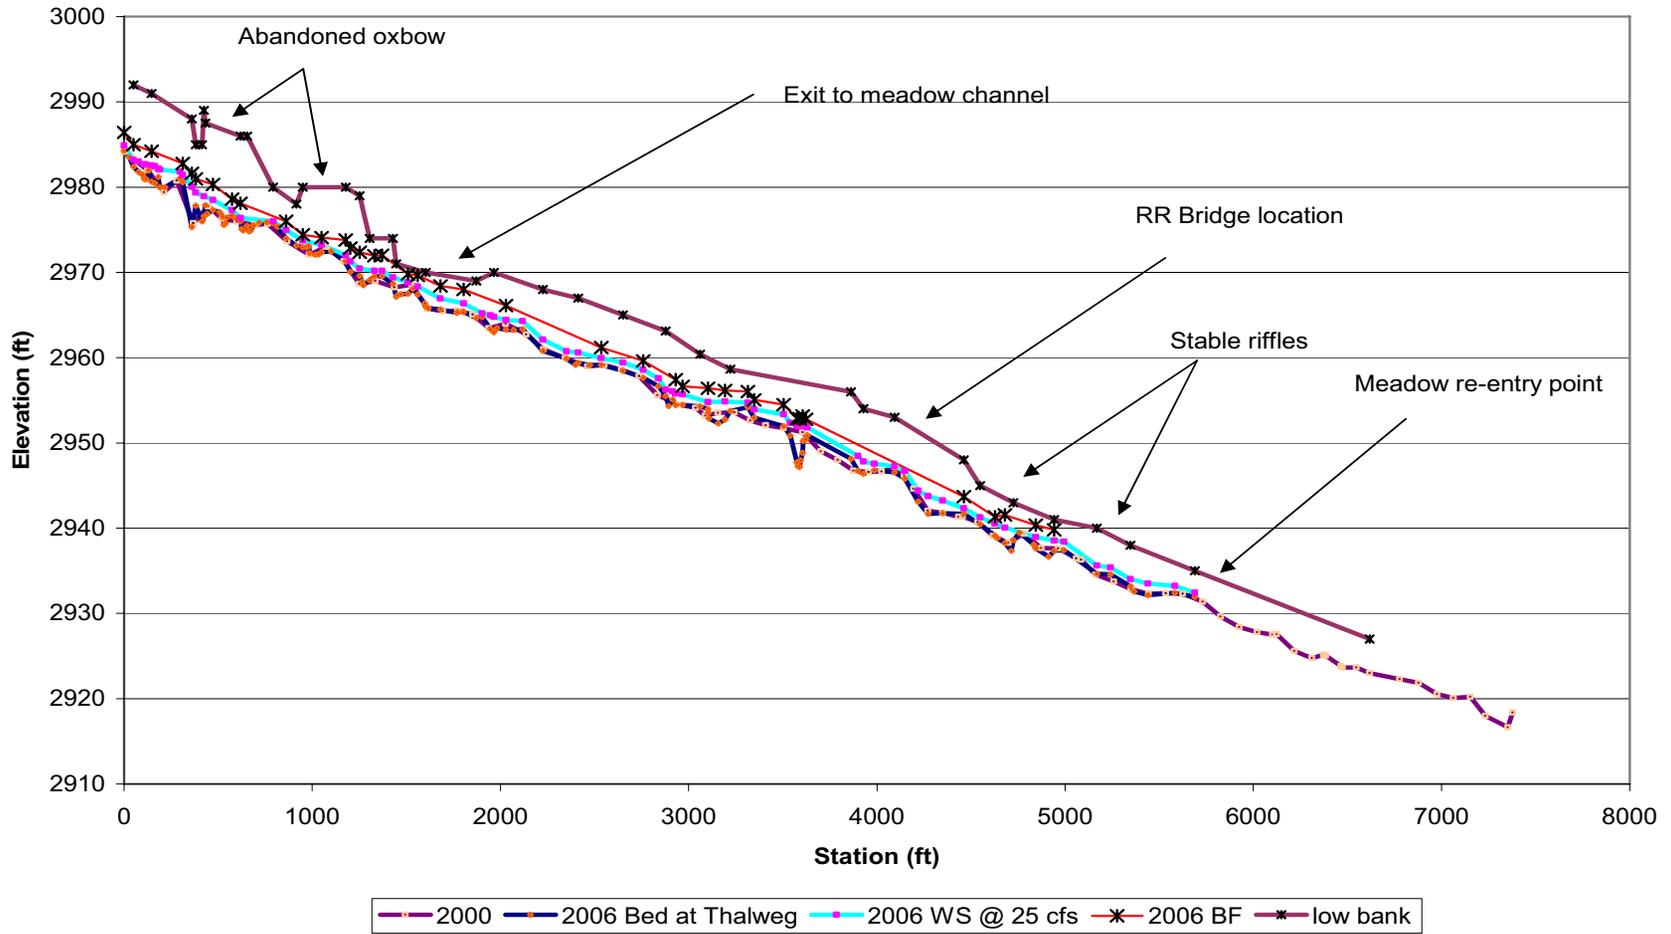
Figure 11. Comparison of 2000 and 2006 longitudinal profiles.

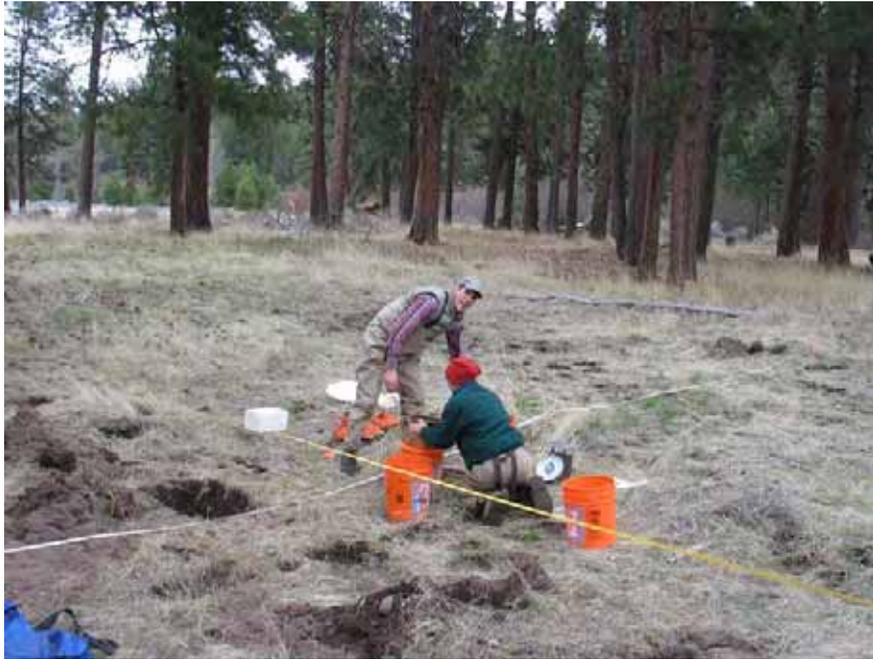
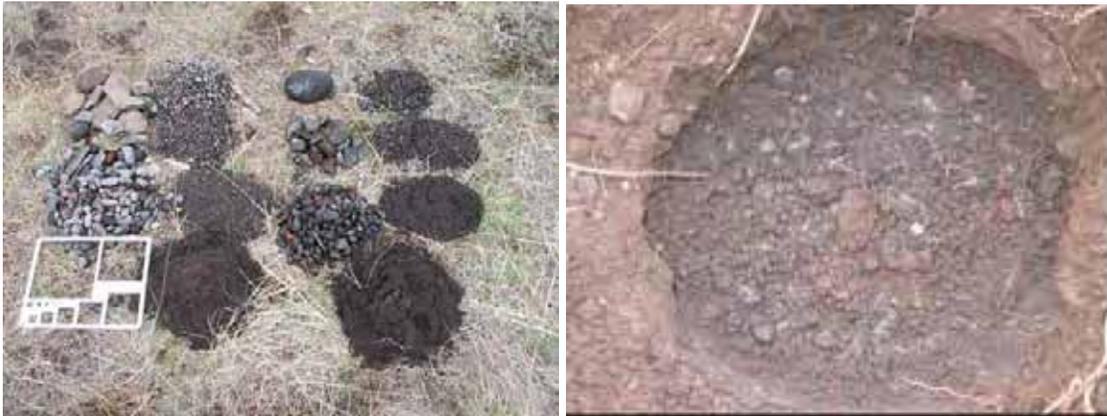
Figure 12. Pavement / sub-pavement samples in the relic channel. Excavating pavement / sub-pavement samples (top), (bottom left) sieved pavement on left, sieved sub-pavement on right, and (bottom right) five inches beneath surface of meadow.

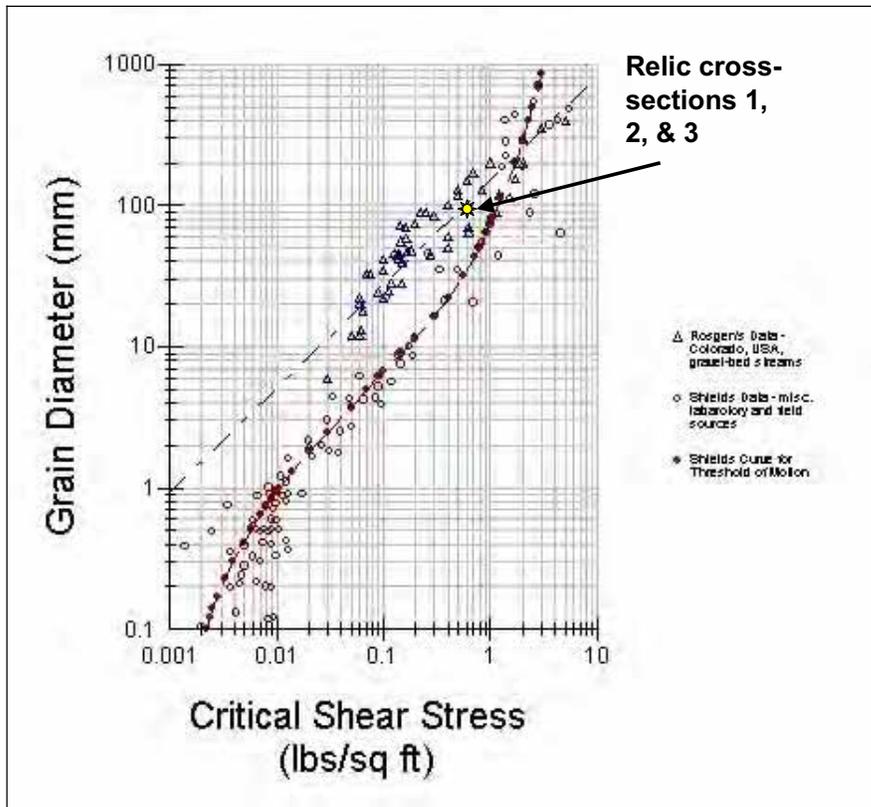
Figure 13. Modified Shields diagram.

Entrainment calculations based on the Rosgen methodology (Rosgen 2005) indicated that the shear stress on the bed of the proposed meadow channel will be within the acceptable range (**Figure 13**). Analysis of sub-pavement samples and test pits collected at Camp Polk indicate that substrate size in the relic channel is similar to stable riffles in the low gradient portion of the existing channel. Therefore, if a riffle in the current channel is stable (not aggrading or degrading) with an average bankfull (1.5 year RI) area of 60ft², average depth of 1.9 feet, and a sub-pavement D84 particle size of approximately 45 mm, the proposed meadow channel would also be stable given the same dimensions.

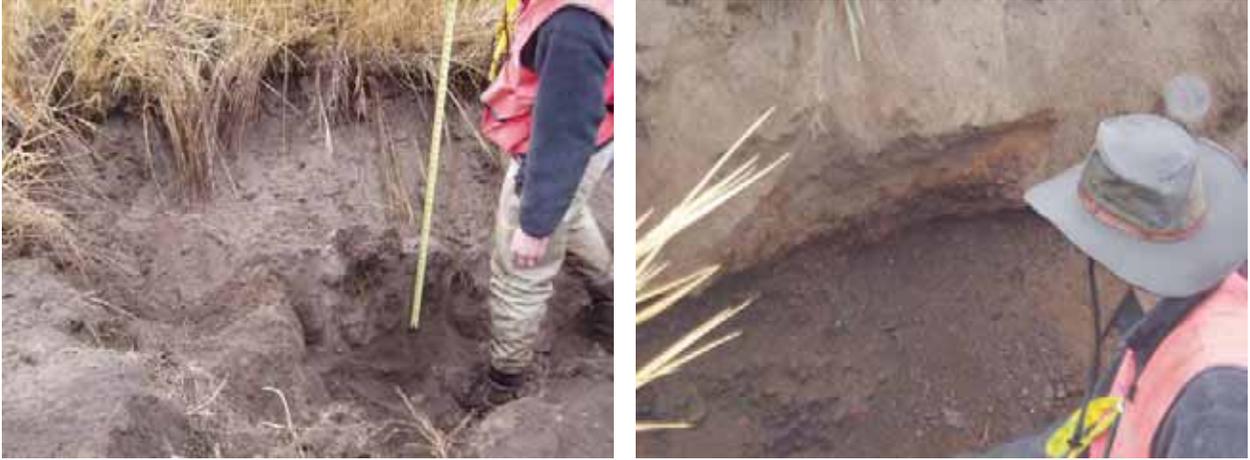
Figure 14. Soil pit in Reach 3.
Pit located above Duckett Pond showing the depth and size of relic channel bed.

The substrate observed in the pits above Duckett Pond (Reach 3) was generally small (*i.e.*, small gravels and sand), and found approximately 3.5 feet below the valley elevation (**Figure 14**). Pits in the upper part of this reach were excavated across the valley. Substrate was relatively uniform through this cross section with the exception of fill material over the bed in some locations. This indicates that the relic channel in this location may have been more of an E4/5 stream type, with high sinuosity and lower width-to-depth ratio (deeper and narrower). Down valley of the Duckett Pond, the substrate in the relic channel was similar in size to the existing channel (gravel and cobble) and approximately 1.5 ft below the valley elevation, suggesting that this reach may have been more characteristic of a C3/4 stream type (**Figure 15**).

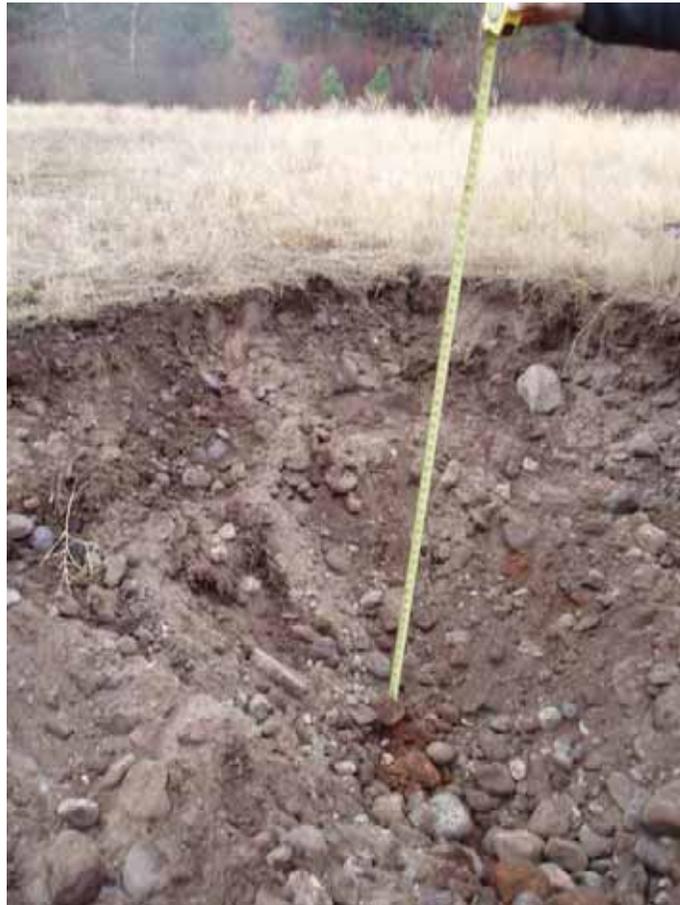
Figure 15. Soil pit in Reach 4.
Pit located below Duckett Pond showing the depth and size of relic channel bed.

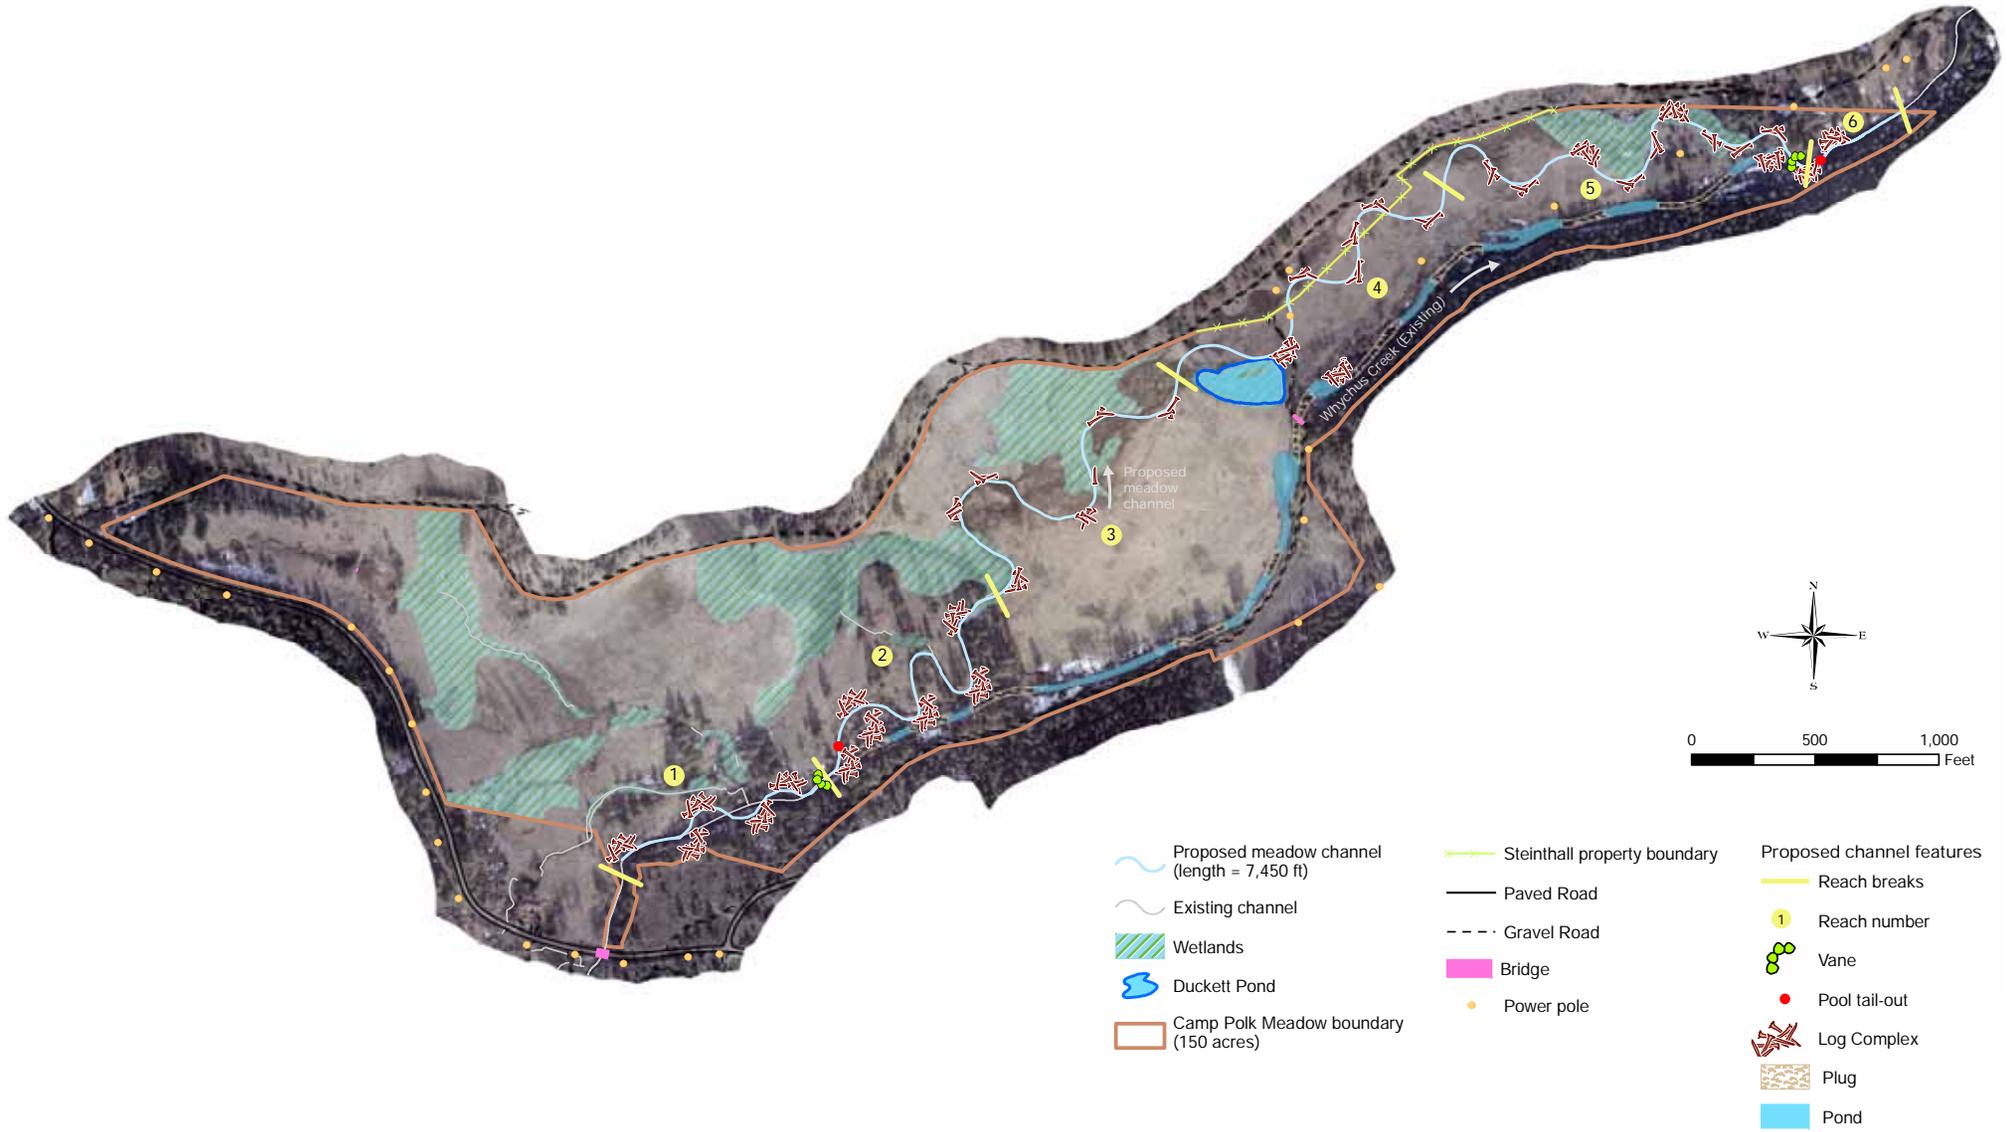
Figure 16. Proposed meadow channel.

In addition, the floodprone width in Reach 1 would be increased from 50 feet to 220 feet. Relic meander bends and oxbows upstream of the entrance to the meadow would be reactivated, which would add 120 feet of stream length, decrease average slope, and increase sinuosity. The transition point between the existing channel and the proposed meadow channel would be at a pool and this feature would be enhanced with a rock and log structure. Grade control structures at the head and tail-out of this pool would provide stability at this transition. An existing relief channel may be accessed by peak flows, adding at least 500 feet of side channel habitat.

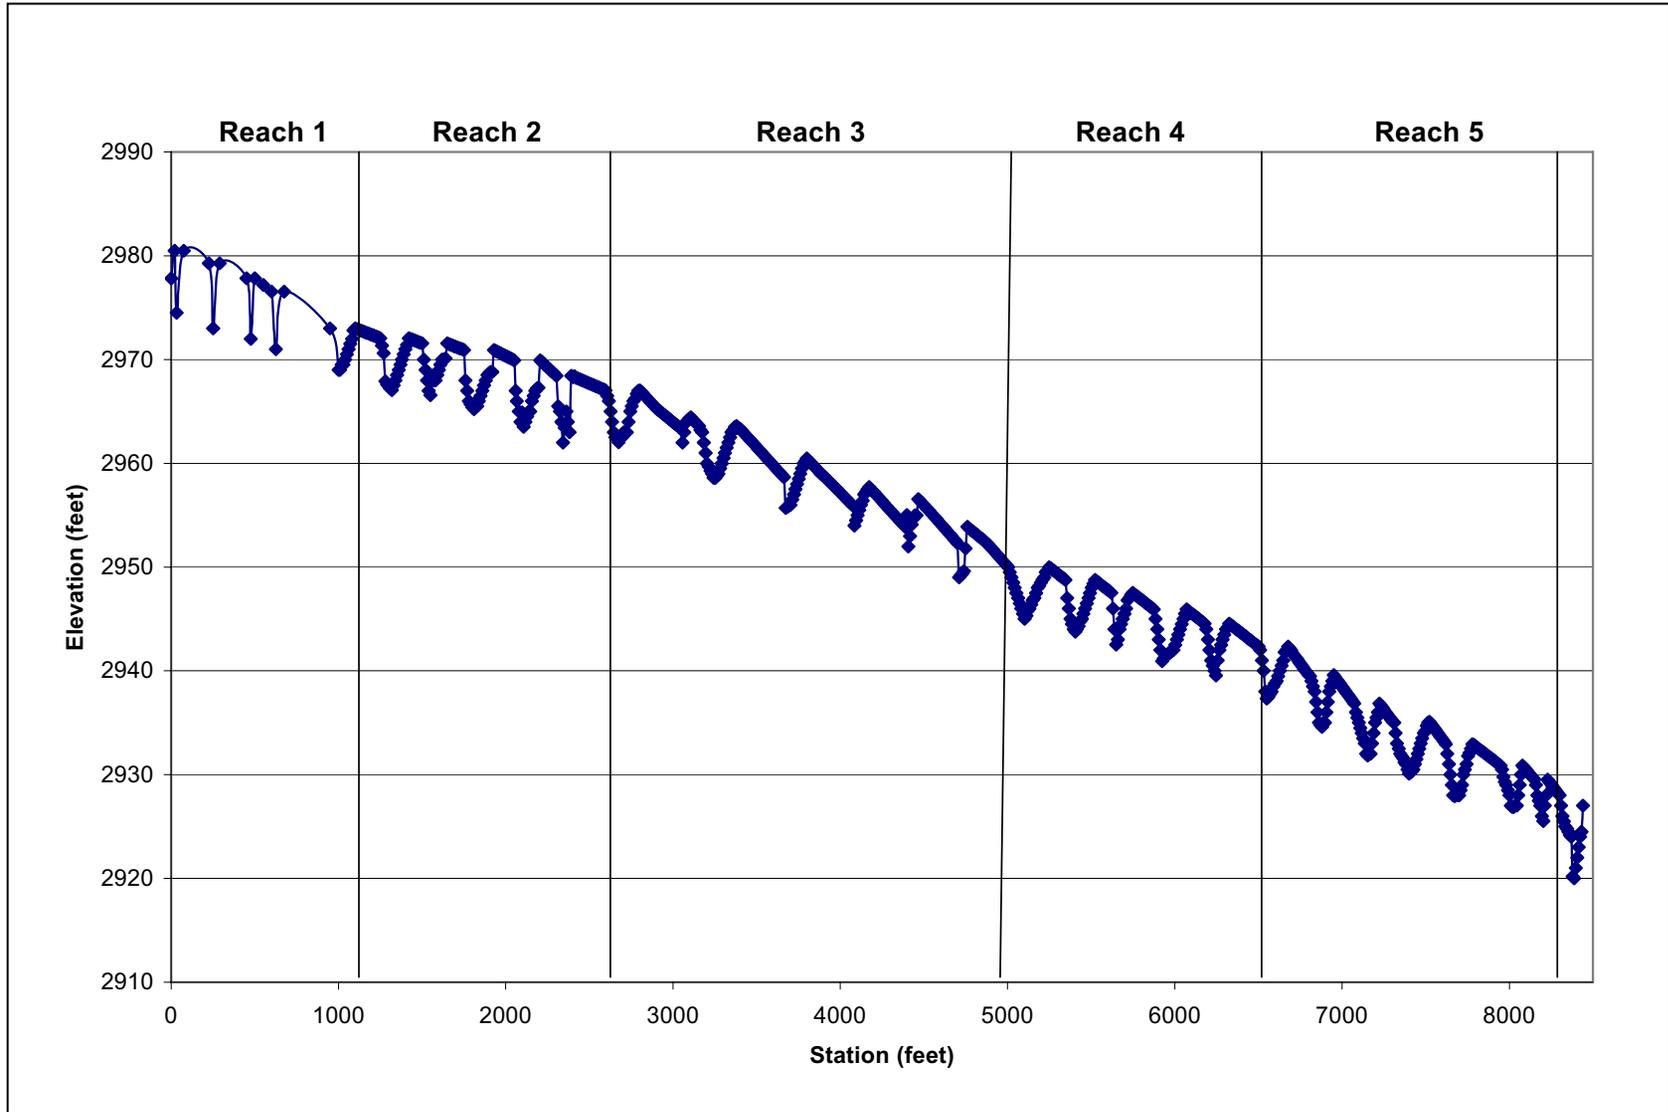
Figure 17. Longitudinal profile of meadow channel

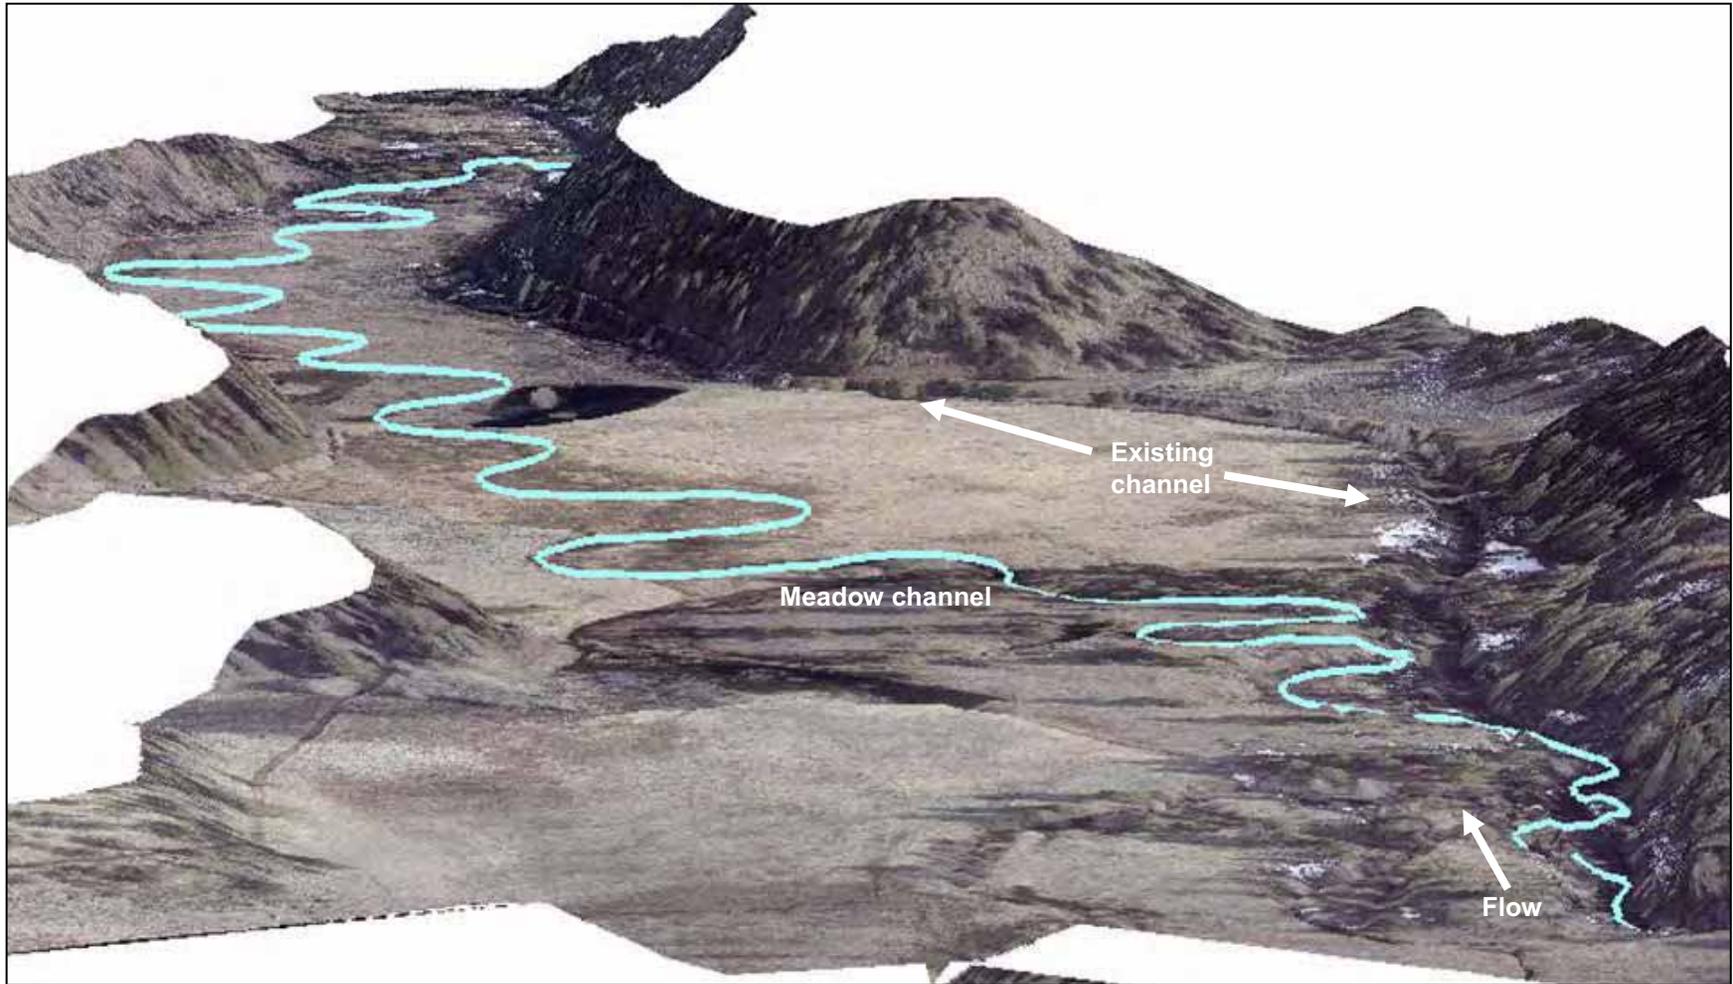
Figure 18. Three dimensional schematic of meadow channel

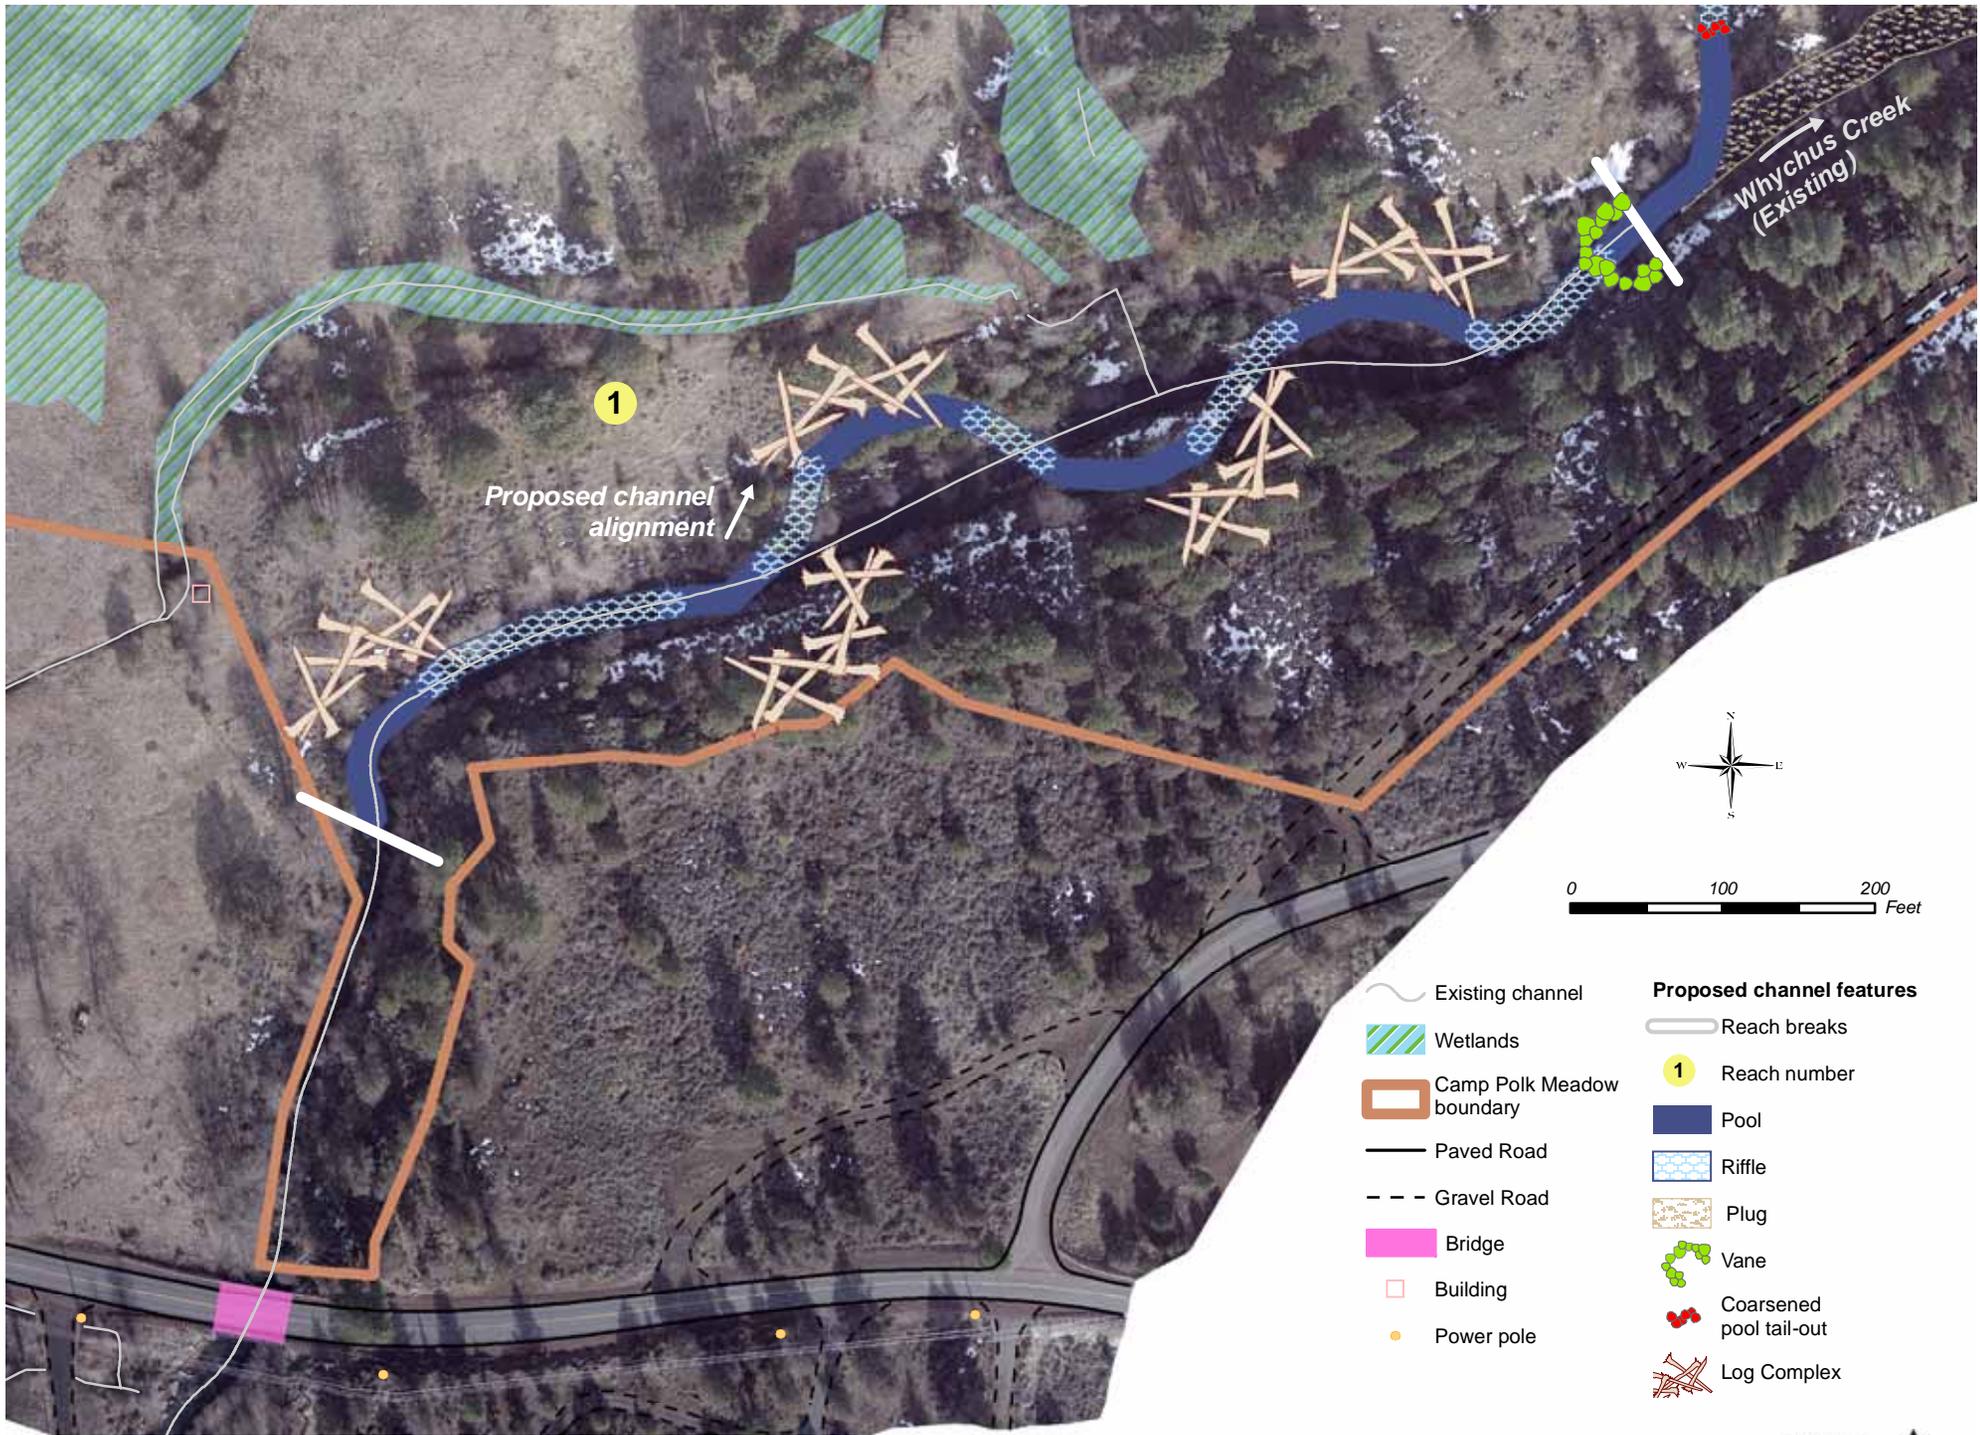
Figure 19. Reach 1 proposed channel alignment.
