Whychus Creek Restoration Project at Camp Polk Meadow Preserve

June 29, 2007

A collaborative project of the:
**Upper Deschutes Watershed Council
Deschutes Basin Land Trust
Deschutes National Forest**

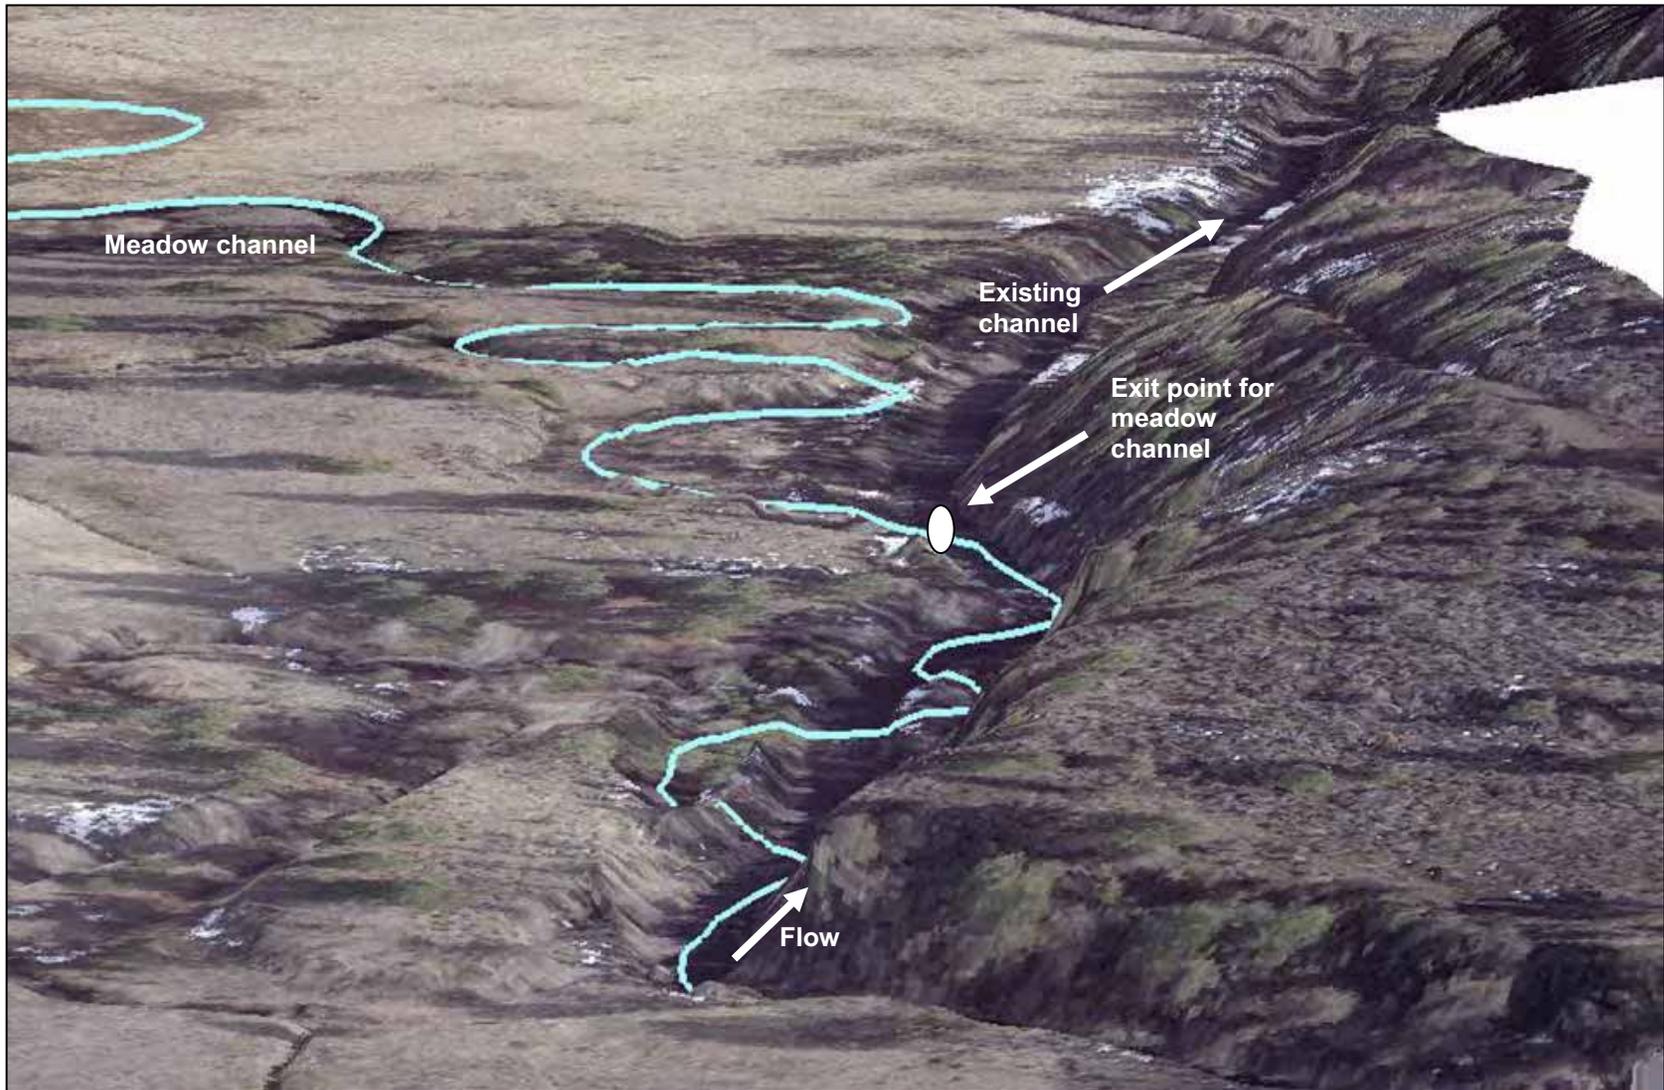
Figure 20. Reach 1 three dimensional schematic.

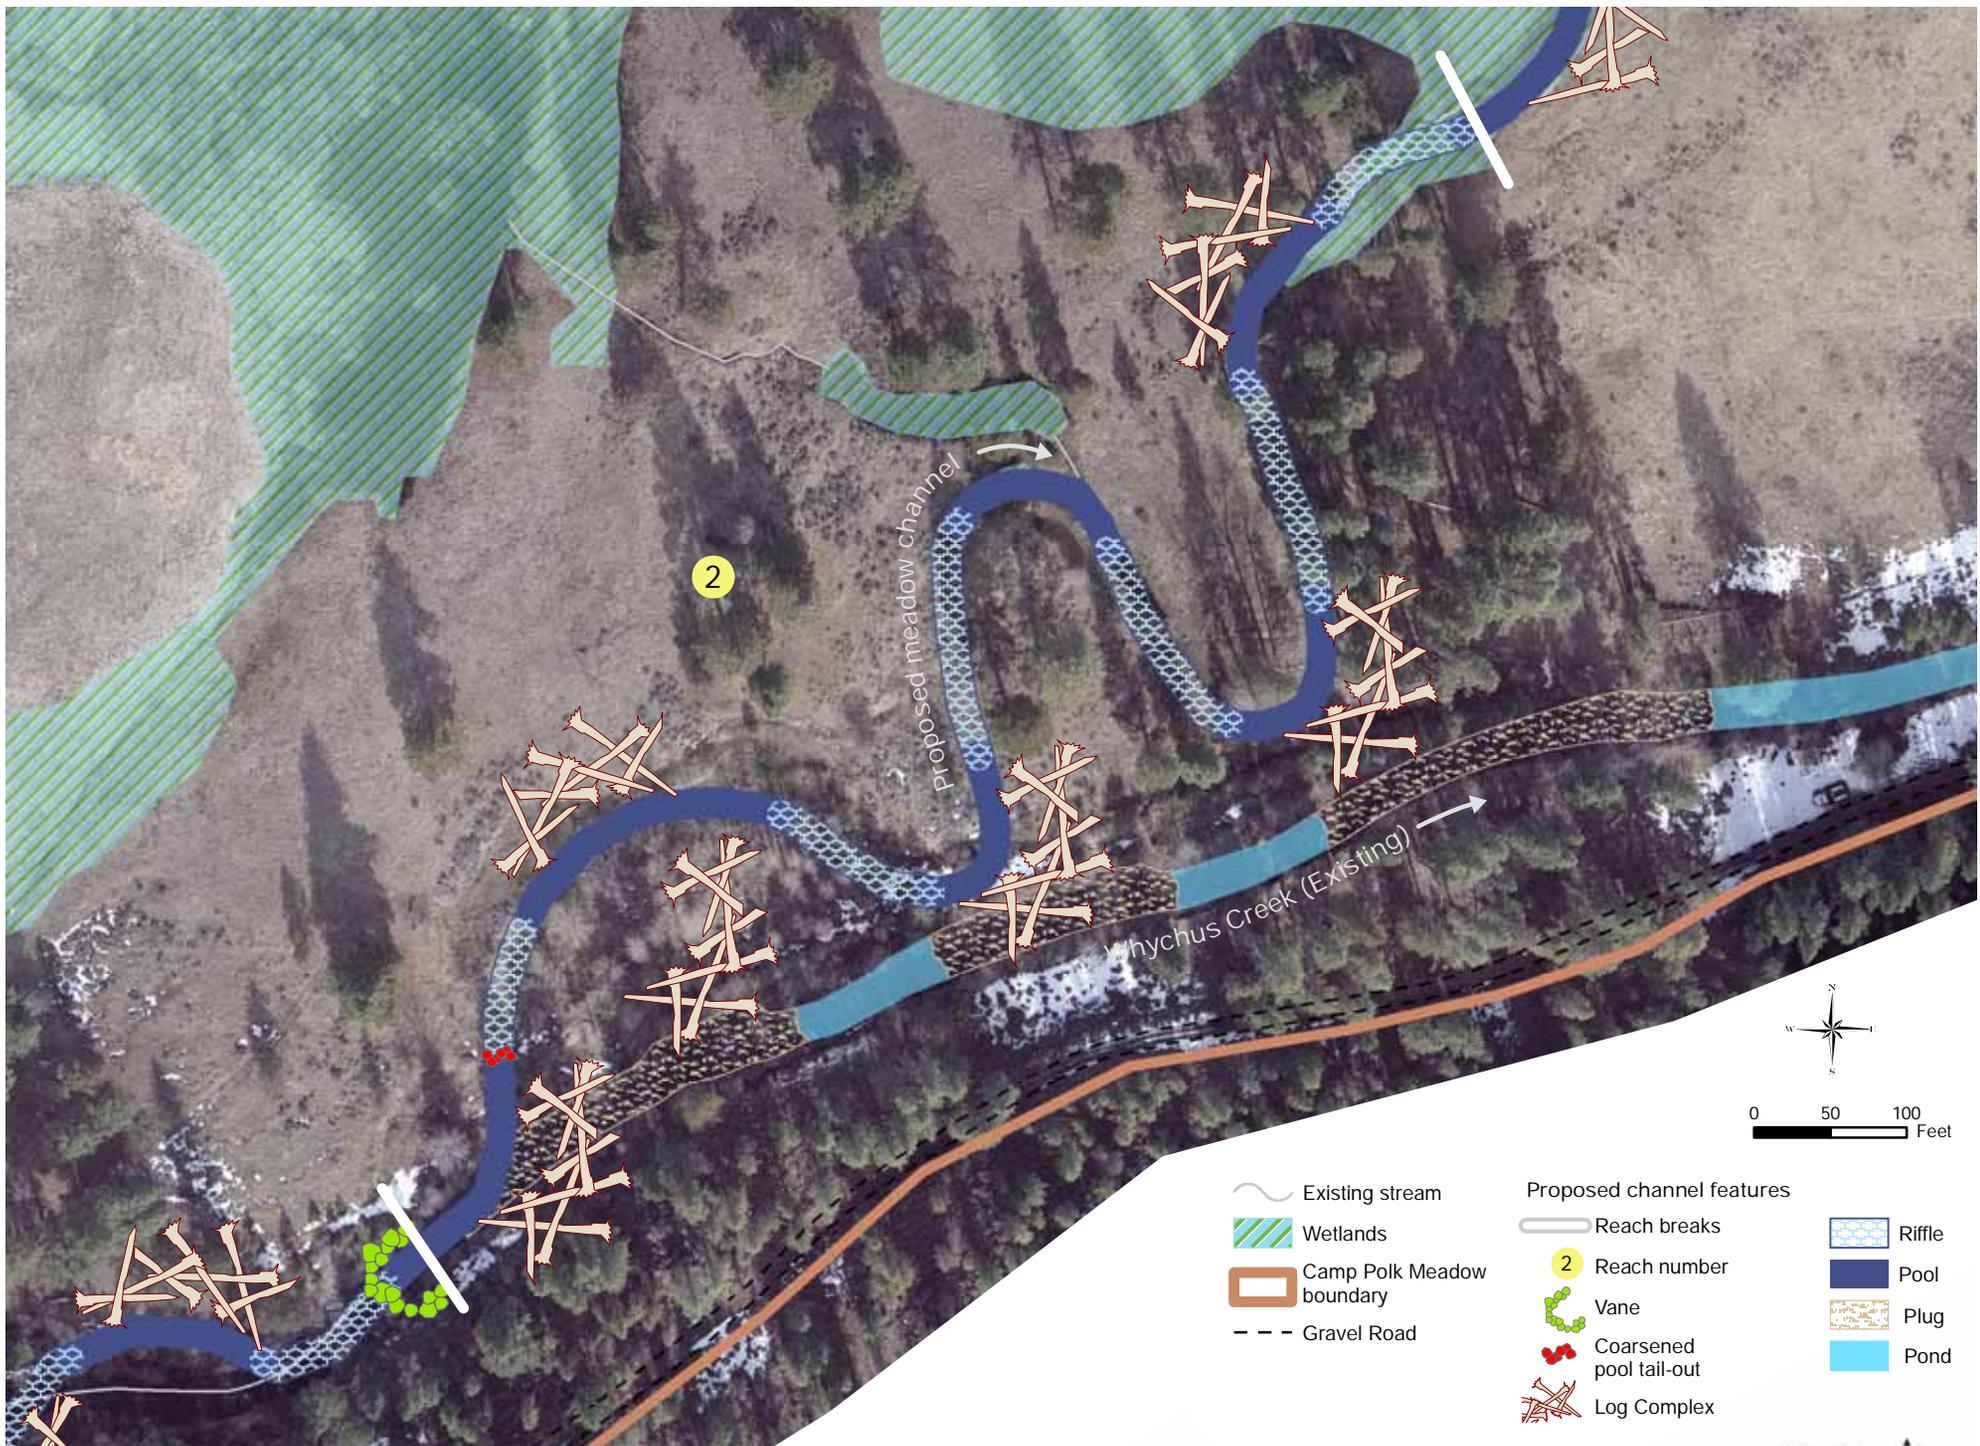
Figure 21. Reach 2 proposed channel alignment.

As in all reaches, the bed would be shaped to have narrow pool heads, wide pool tailouts, and max pool depths at meander apexes. The tailout of the pool at the transition from the existing channel (Reach 1) to the proposed meadow channel (beginning of meadow channel) would be coarsened with a grade control structure to help prevent a lowering of the tail-out at the change in grade. Before the proposed meadow channel would carry the full flow of Whychus Creek, the current channel alignment would be plugged. Plugging the current channel will reduce the risk of stream recapture and allow the recovery of the water table in the meadow. If the current channel were to remain un-plugged, it would continue to be the low point in the valley, draining groundwater from the meadow, preventing recharge and vegetative recovery.

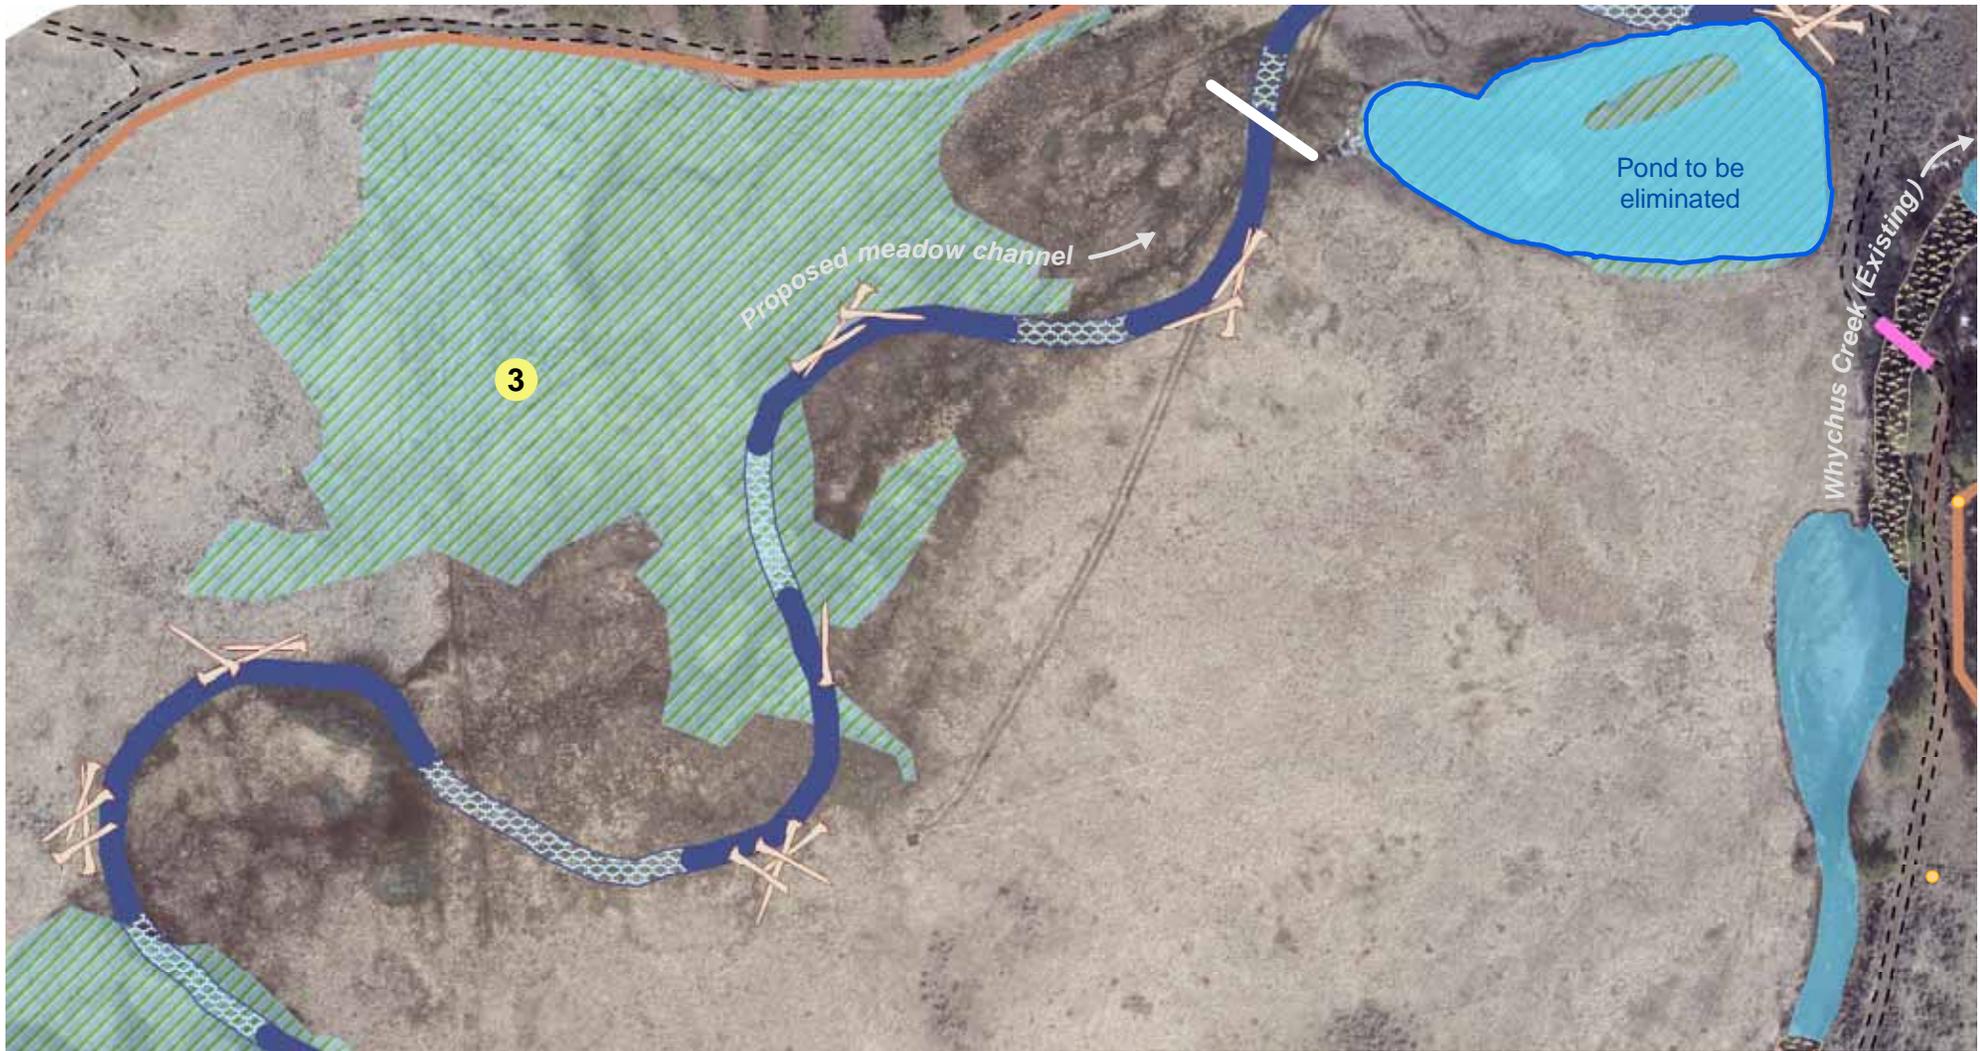
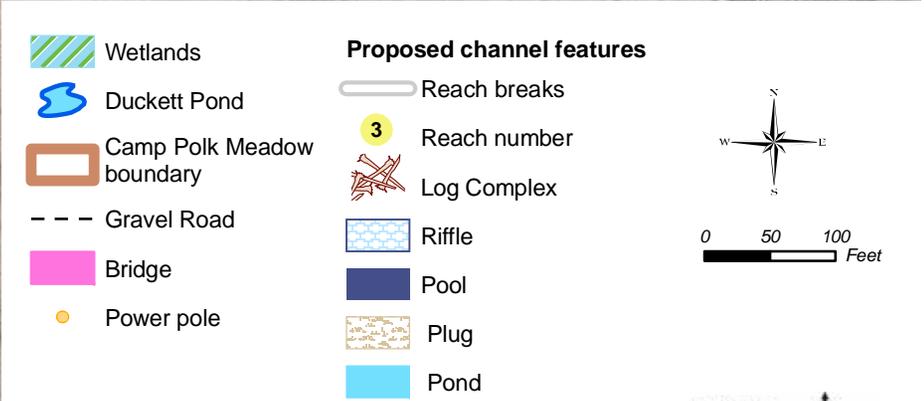
Figure 22. Reach 3 proposed channel alignment.

In general, Reach 3 would be narrower and deeper than the other reaches and the transition between the pools and riffles would be less distinct (*i.e.*, long pools and glides). Wood would be added into the banks and the channel to mimic historic conditions when cottonwood and alders would have fallen into the stream. Wood additions would be low profile, adding complexity to the banks and channel while providing much needed cover for aquatic organisms.

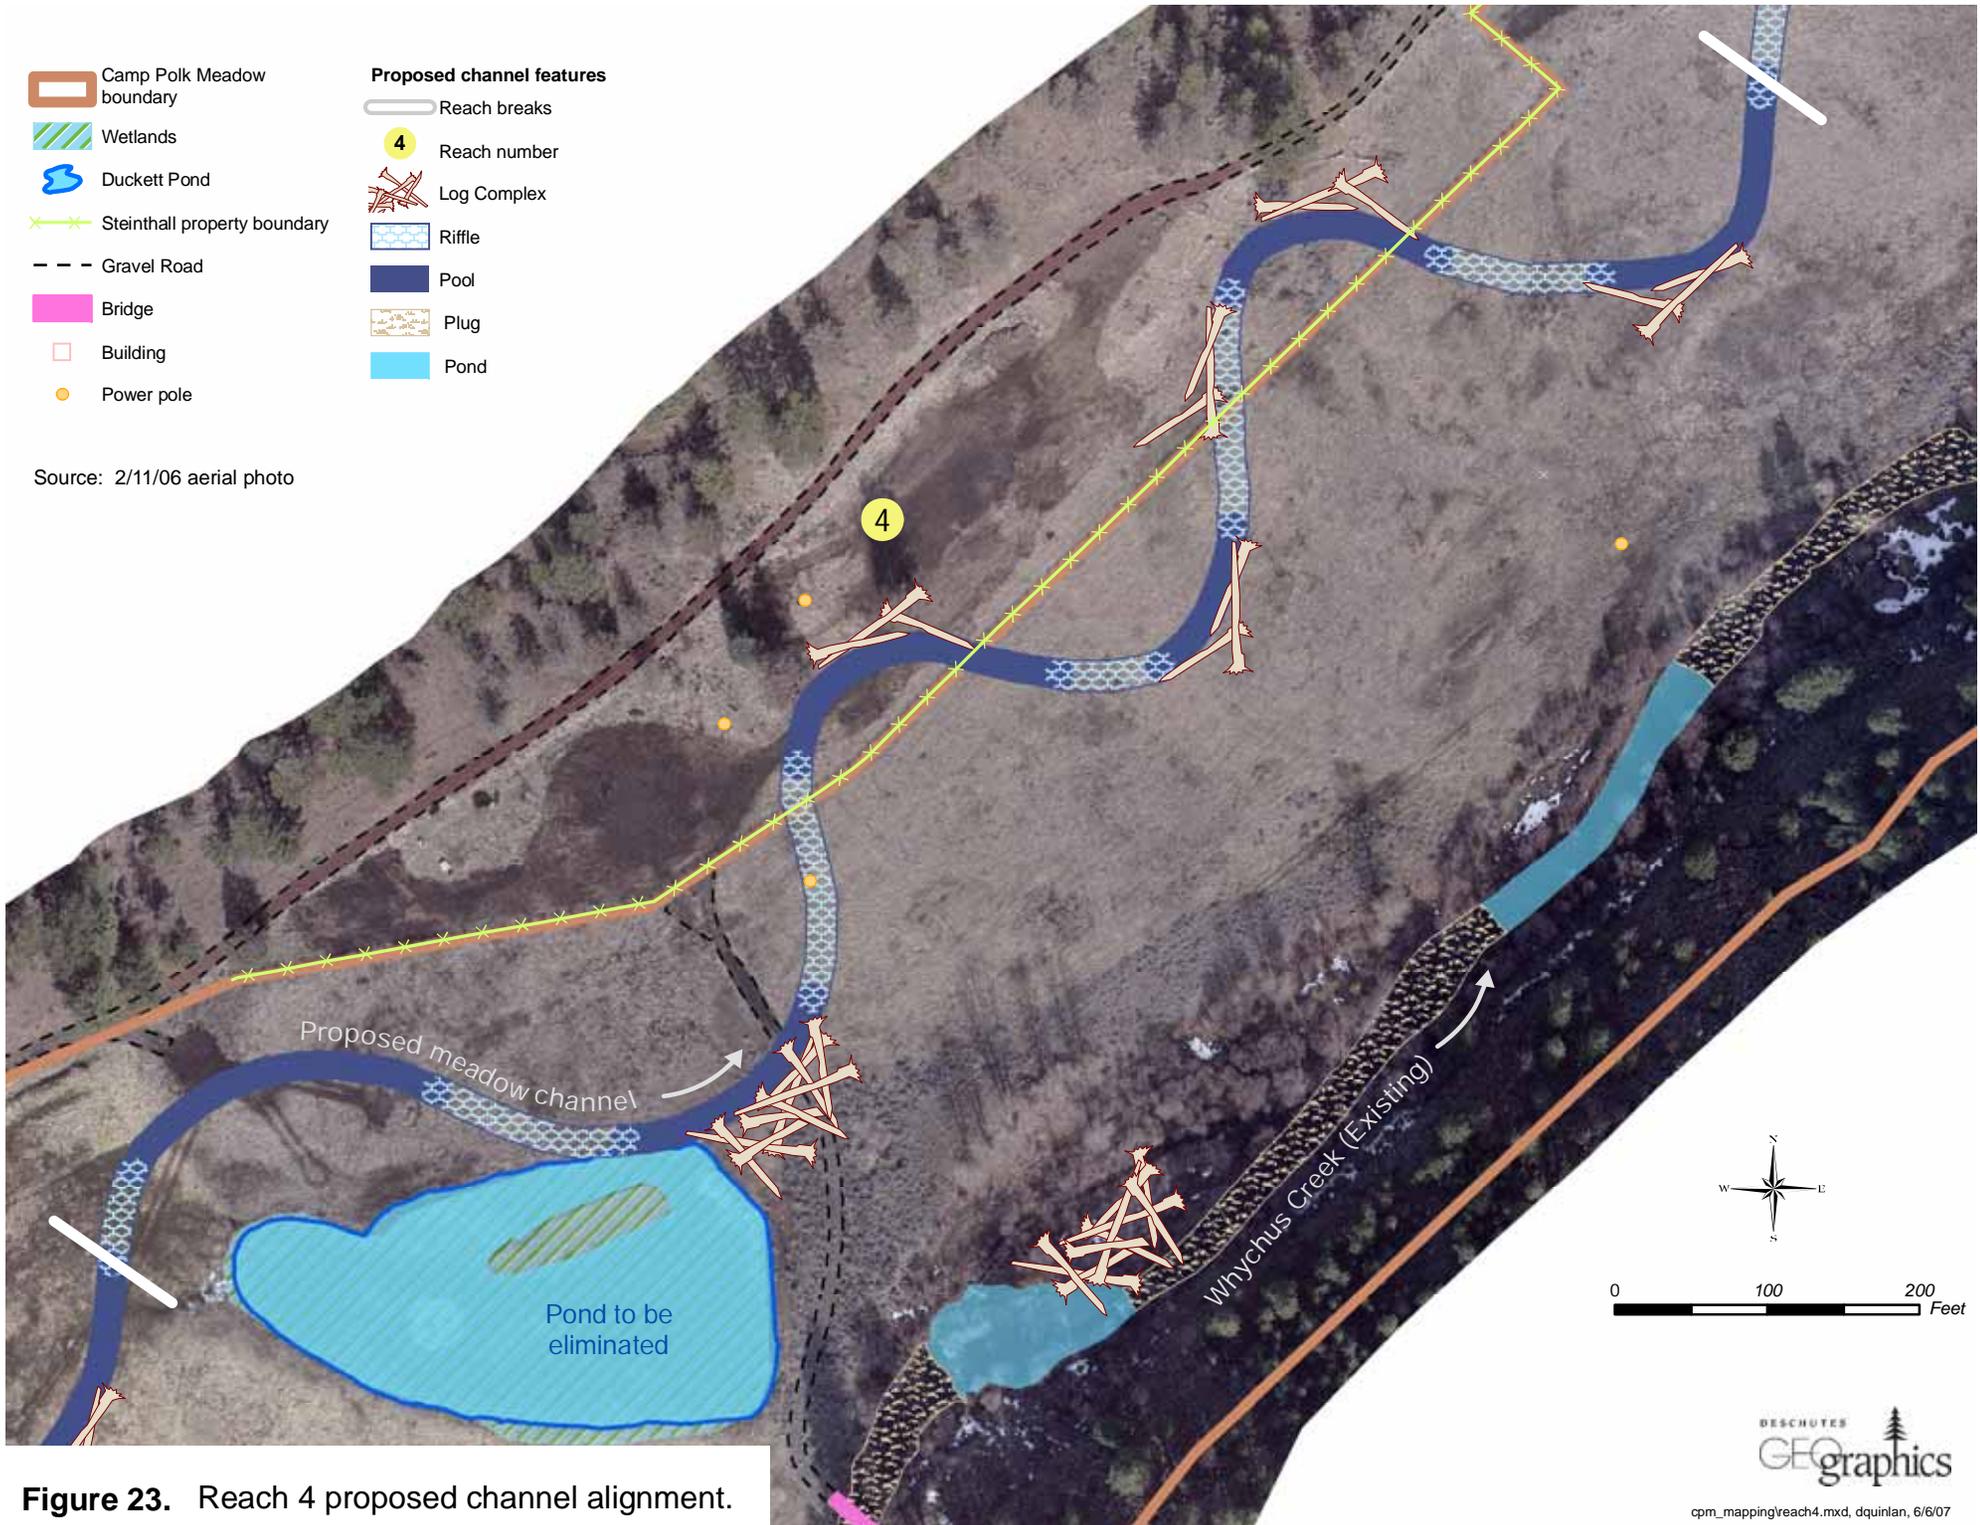
Figure 23. Reach 4 proposed channel alignment.

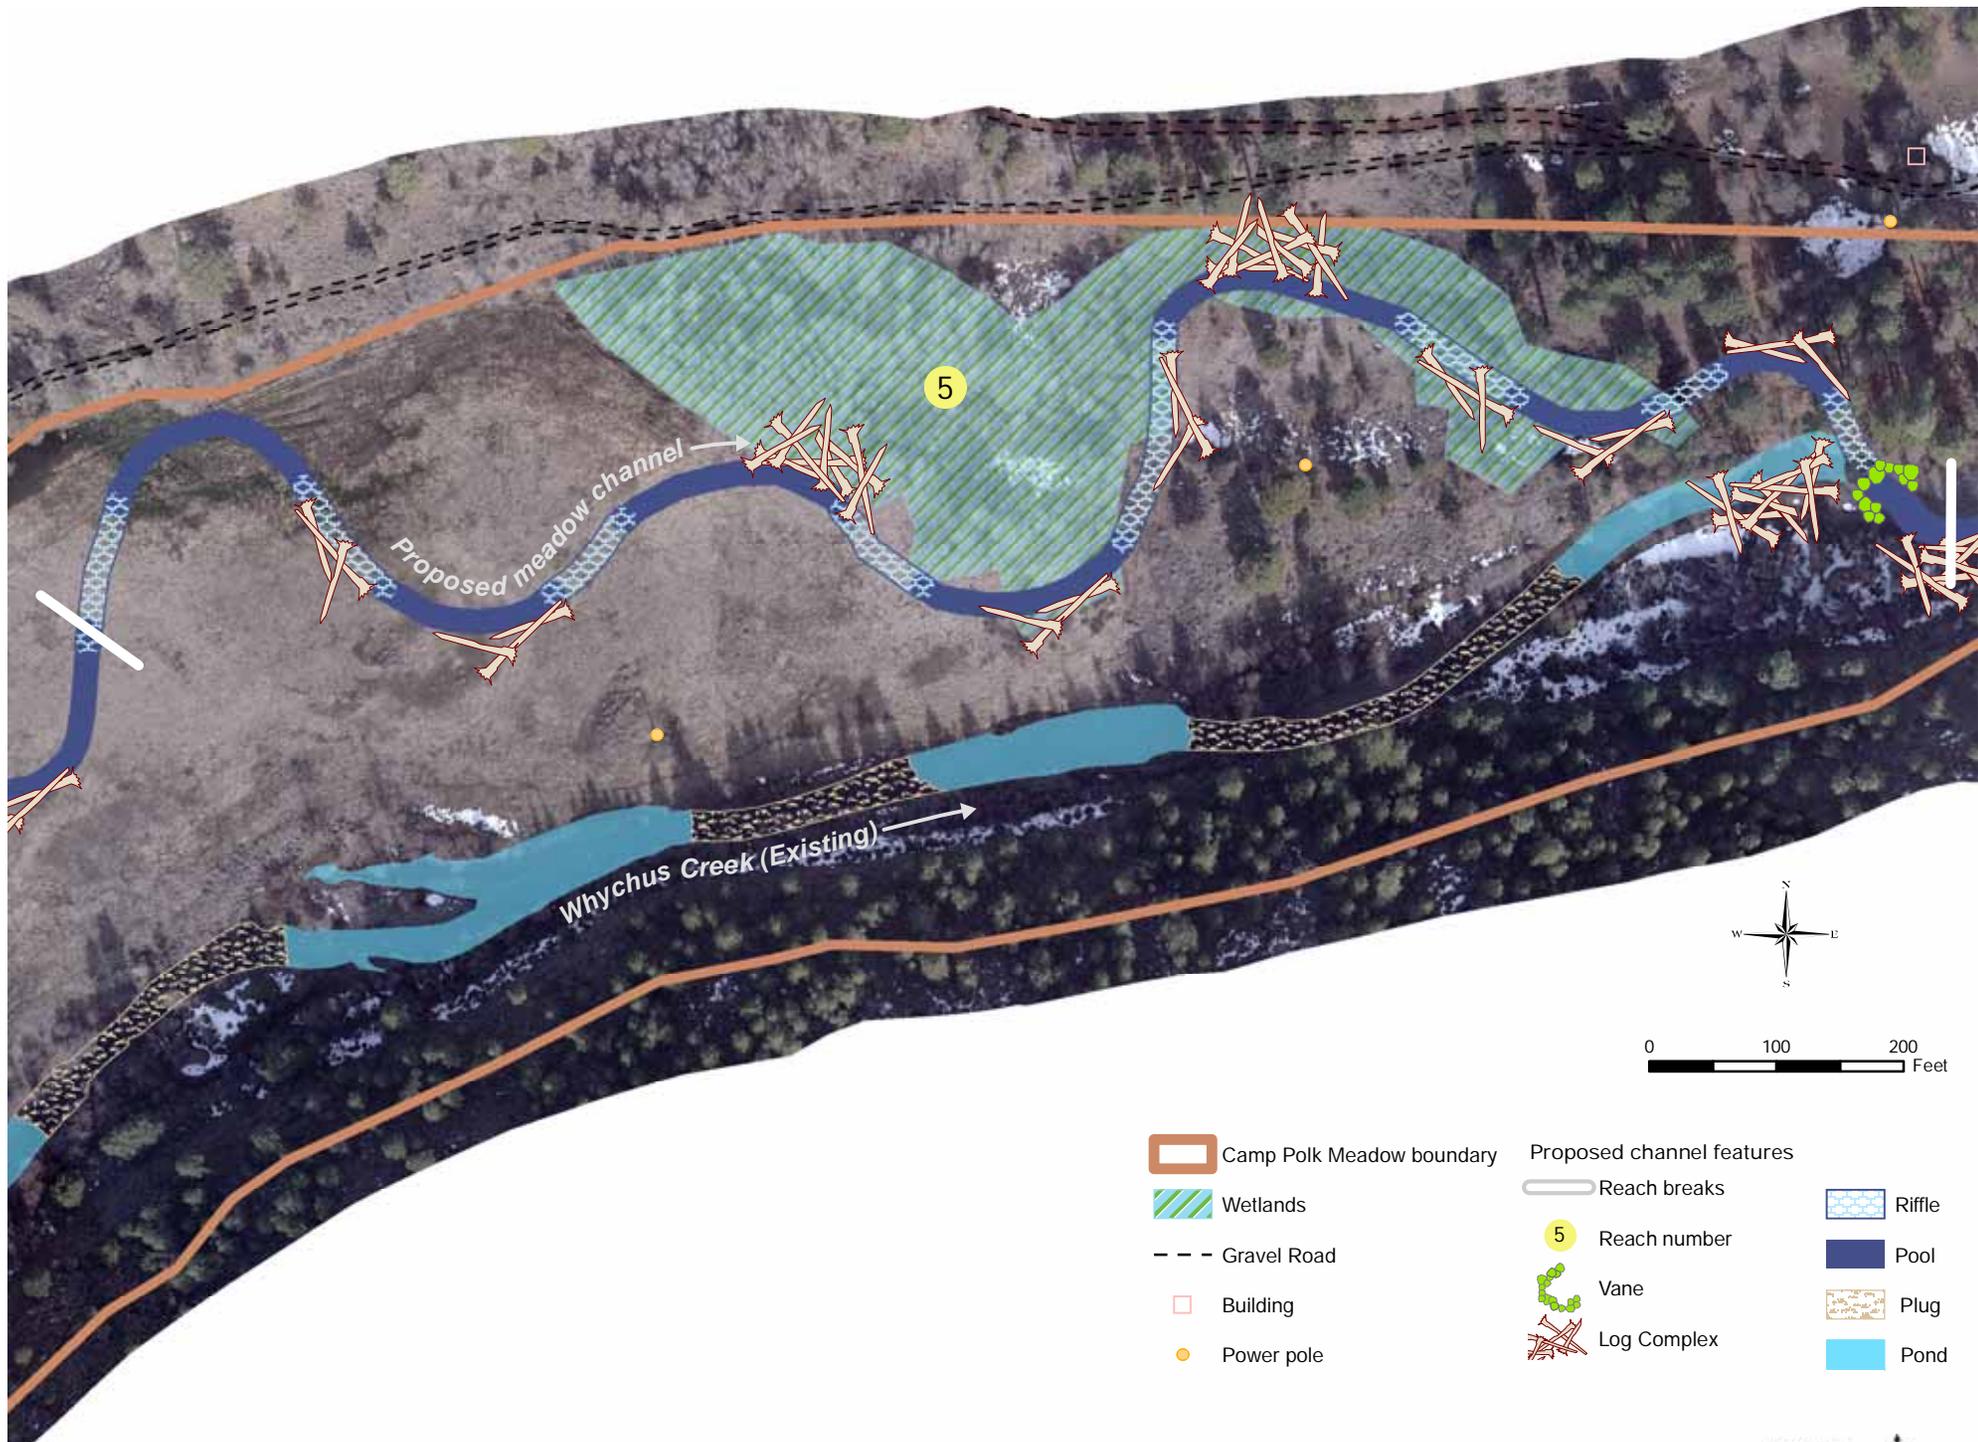
Figure 24. Reach 5 proposed channel alignment.

Reach 5, including approximately 2,000 feet of channel, extends from immediately up-valley of the aspen stand to the exit at the existing channel along the east-end of the property (**Figure 24**). The channel is designed as a C4 stream type and will meander around the aspen stand before entering a relic channel immediately southeast of the stand. The channel skirts the aspen stand because this area provides abundant habitat for neotropical birds and other wildlife and should be preserved intact. This relic channel is heavily vegetated and will provide excellent bank stability, which is particularly important near the transition back into the existing channel. Existing vegetation on the channel bottom will be transplanted along the channel banks in reaches 2, 3, and 4. This would salvage existing vegetation and provide mature vegetation to raw stream banks. Gravel substrate is already present and any seeding is expected to be minimal. Wood complexes will be constructed on the outside of meander bends to help maintain the new channel alignment, maintain pools, and provide habitat complexity.

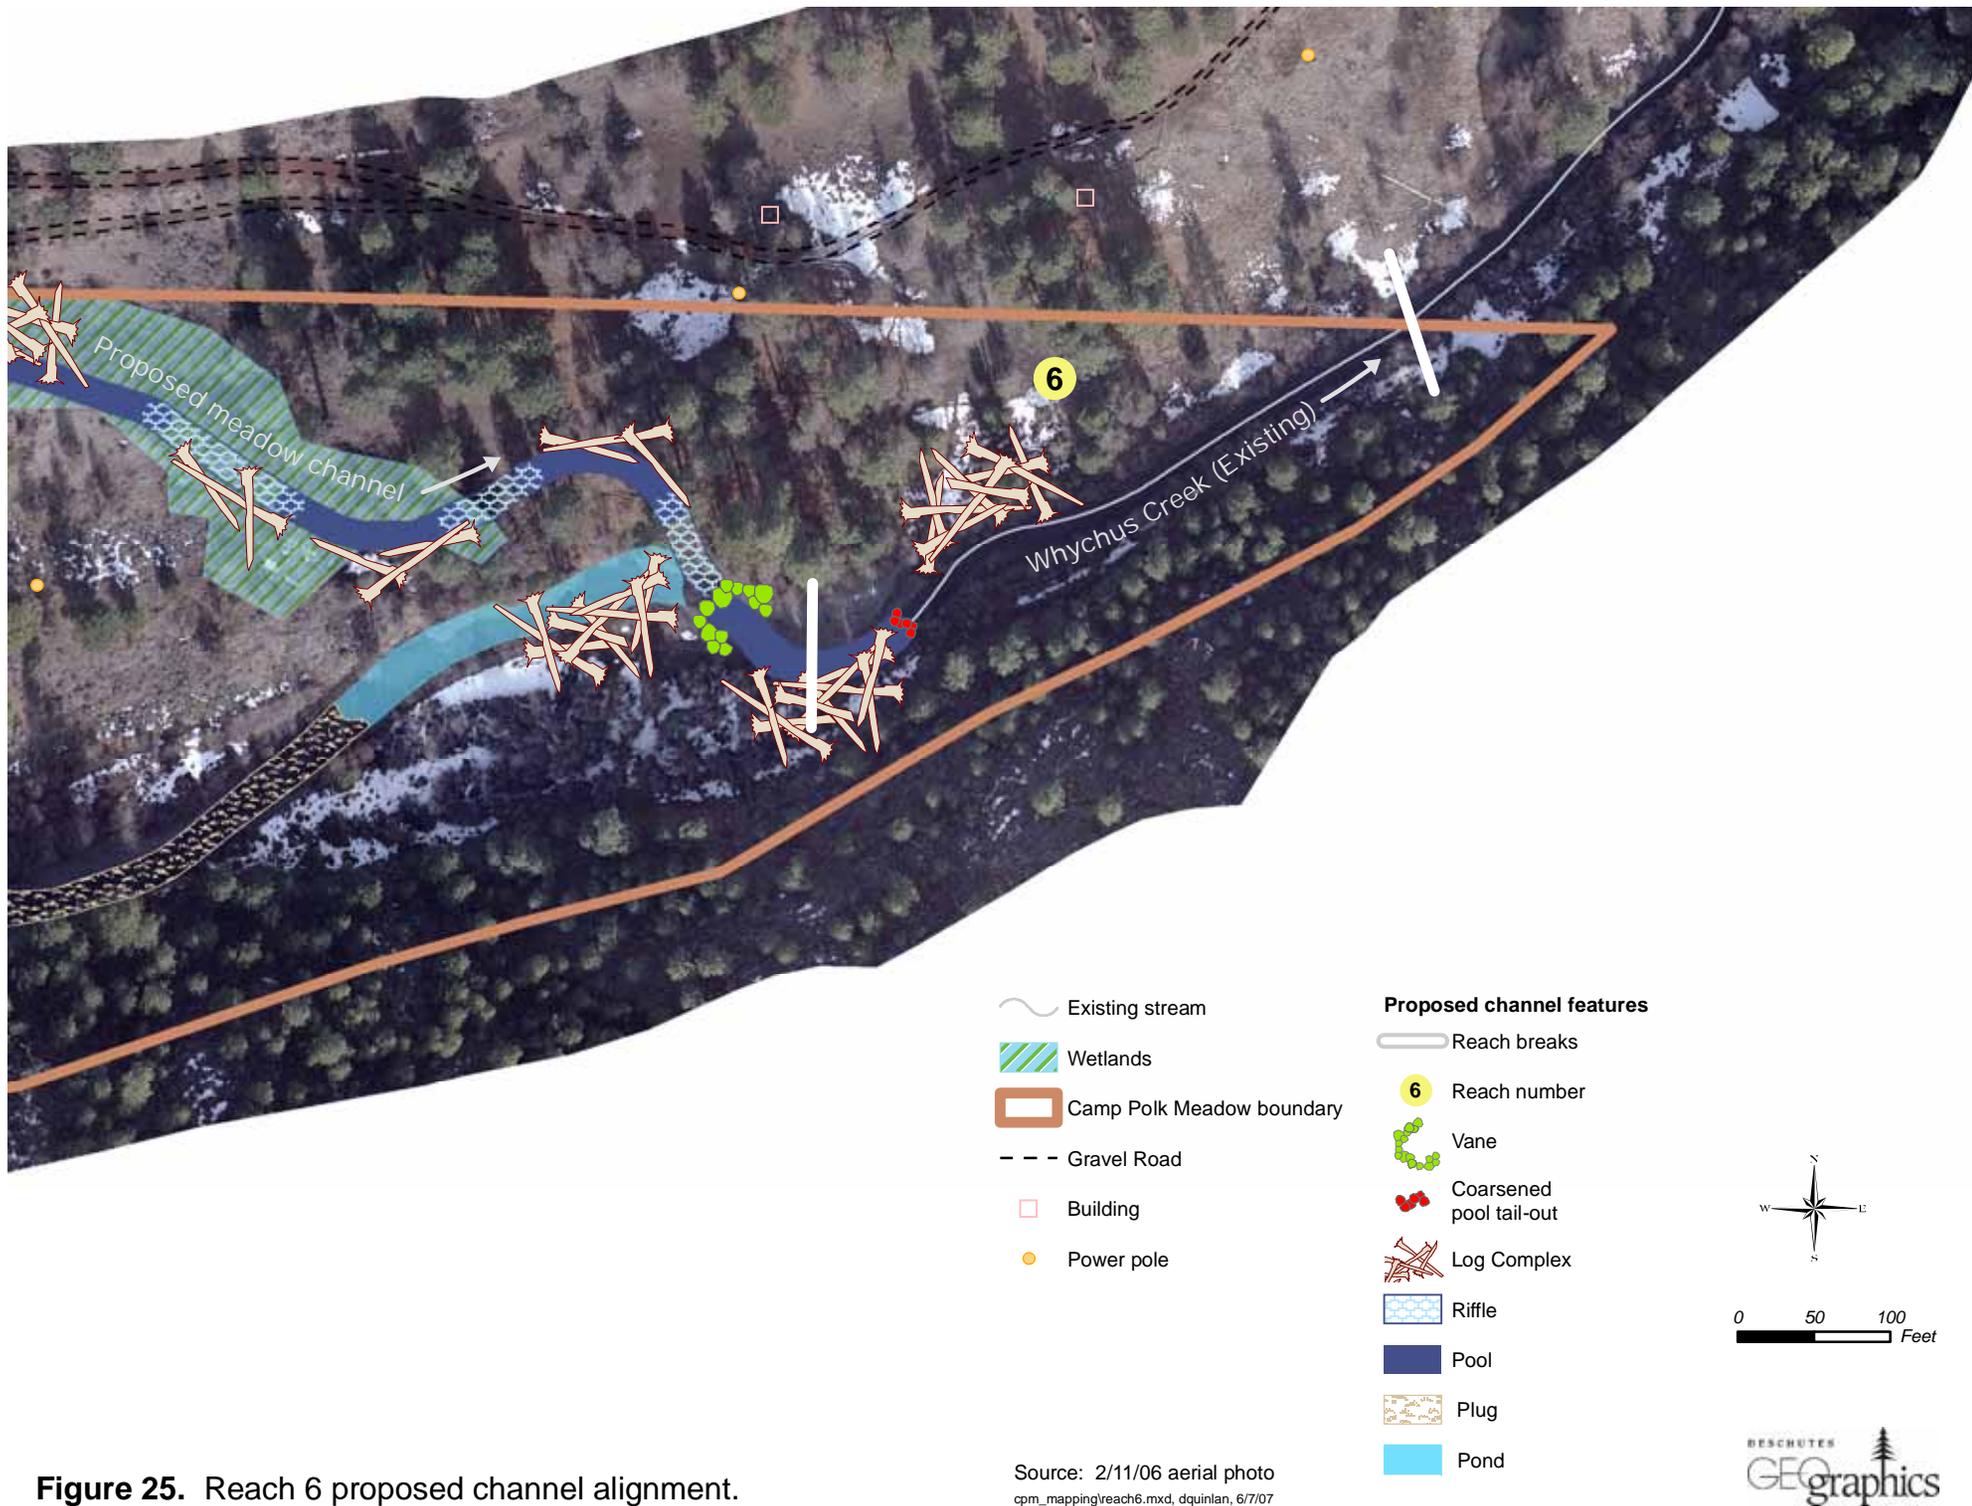
Figure 25. Reach 6 proposed channel alignment.

Reach 6, including approximately 500 feet of channel, lies within the existing channel alignment and extends from the meadow re-entry point to the downstream end of the Camp Polk Meadow property (**Figure 25**). This reach is currently a C4 channel type and will remain so with some minor enhancements. The average bed slope of Reach 6 is 0.7%, which is close to the proposed meadow channel slope of 0.64%. A rock vein will be constructed at the pool head at the transition into the existing channel to maintain the pool and help prevent headcutting into the meadow. Likewise, the pool-tail crest will be coarsened to prevent a drop in base elevation. Wood complexes will be constructed on the outside of three meander bends to help maintain deep pools and provide cover. This location was selected because the elevation difference between the proposed meadow channel and the existing channel is only 1.5 feet, the existing channel is stable at this point and the slopes of the two reaches are similar.

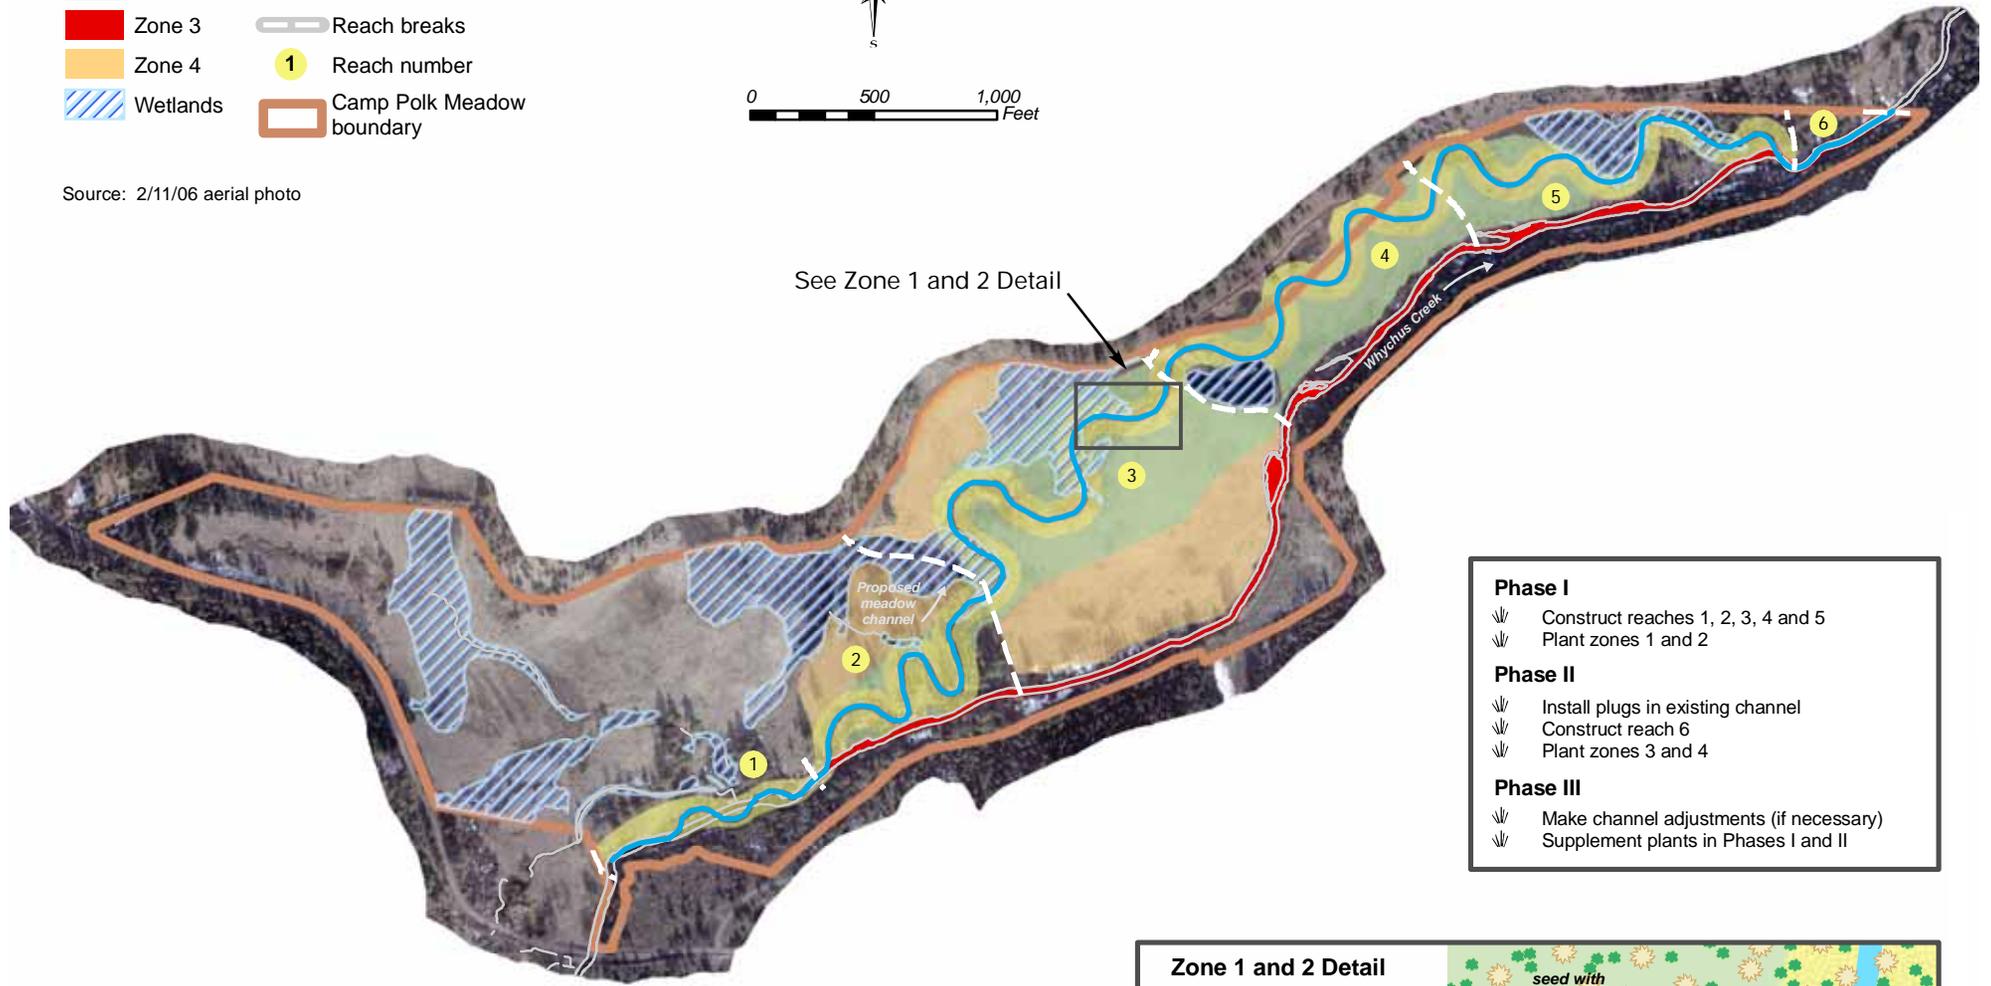
Figure 26. Revegetation Plan: Overview

- Phase I**
- ⚡ Construct reaches 1, 2, 3, 4 and 5
 - ⚡ Plant zones 1 and 2
- Phase II**
- ⚡ Install plugs in existing channel
 - ⚡ Construct reach 6
 - ⚡ Plant zones 3 and 4
- Phase III**
- ⚡ Make channel adjustments (if necessary)
 - ⚡ Supplement plants in Phases I and II

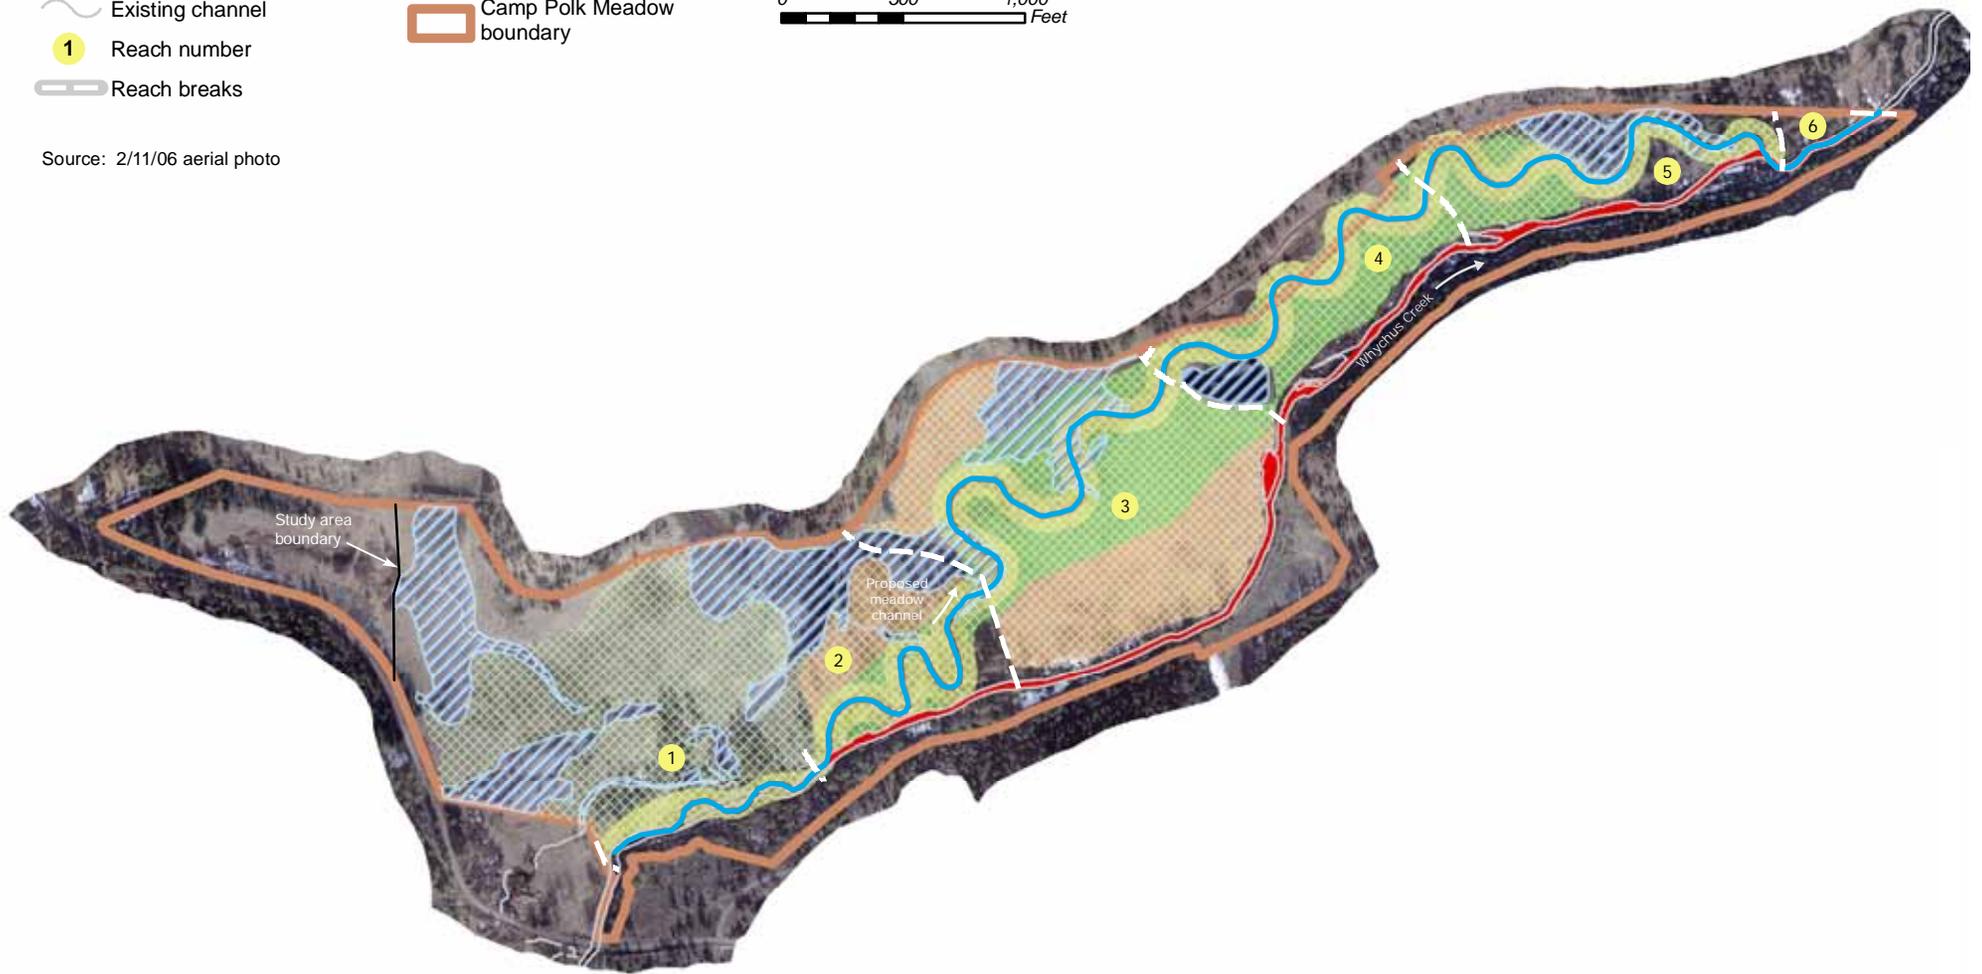
Figure 32. Existing and created wetlands.
