Whychus Creek Restoration Project at Camp Polk Meadow Preserve

June 29, 2007

A collaborative project of the:
**Upper Deschutes Watershed Council
Deschutes Basin Land Trust
Deschutes National Forest**

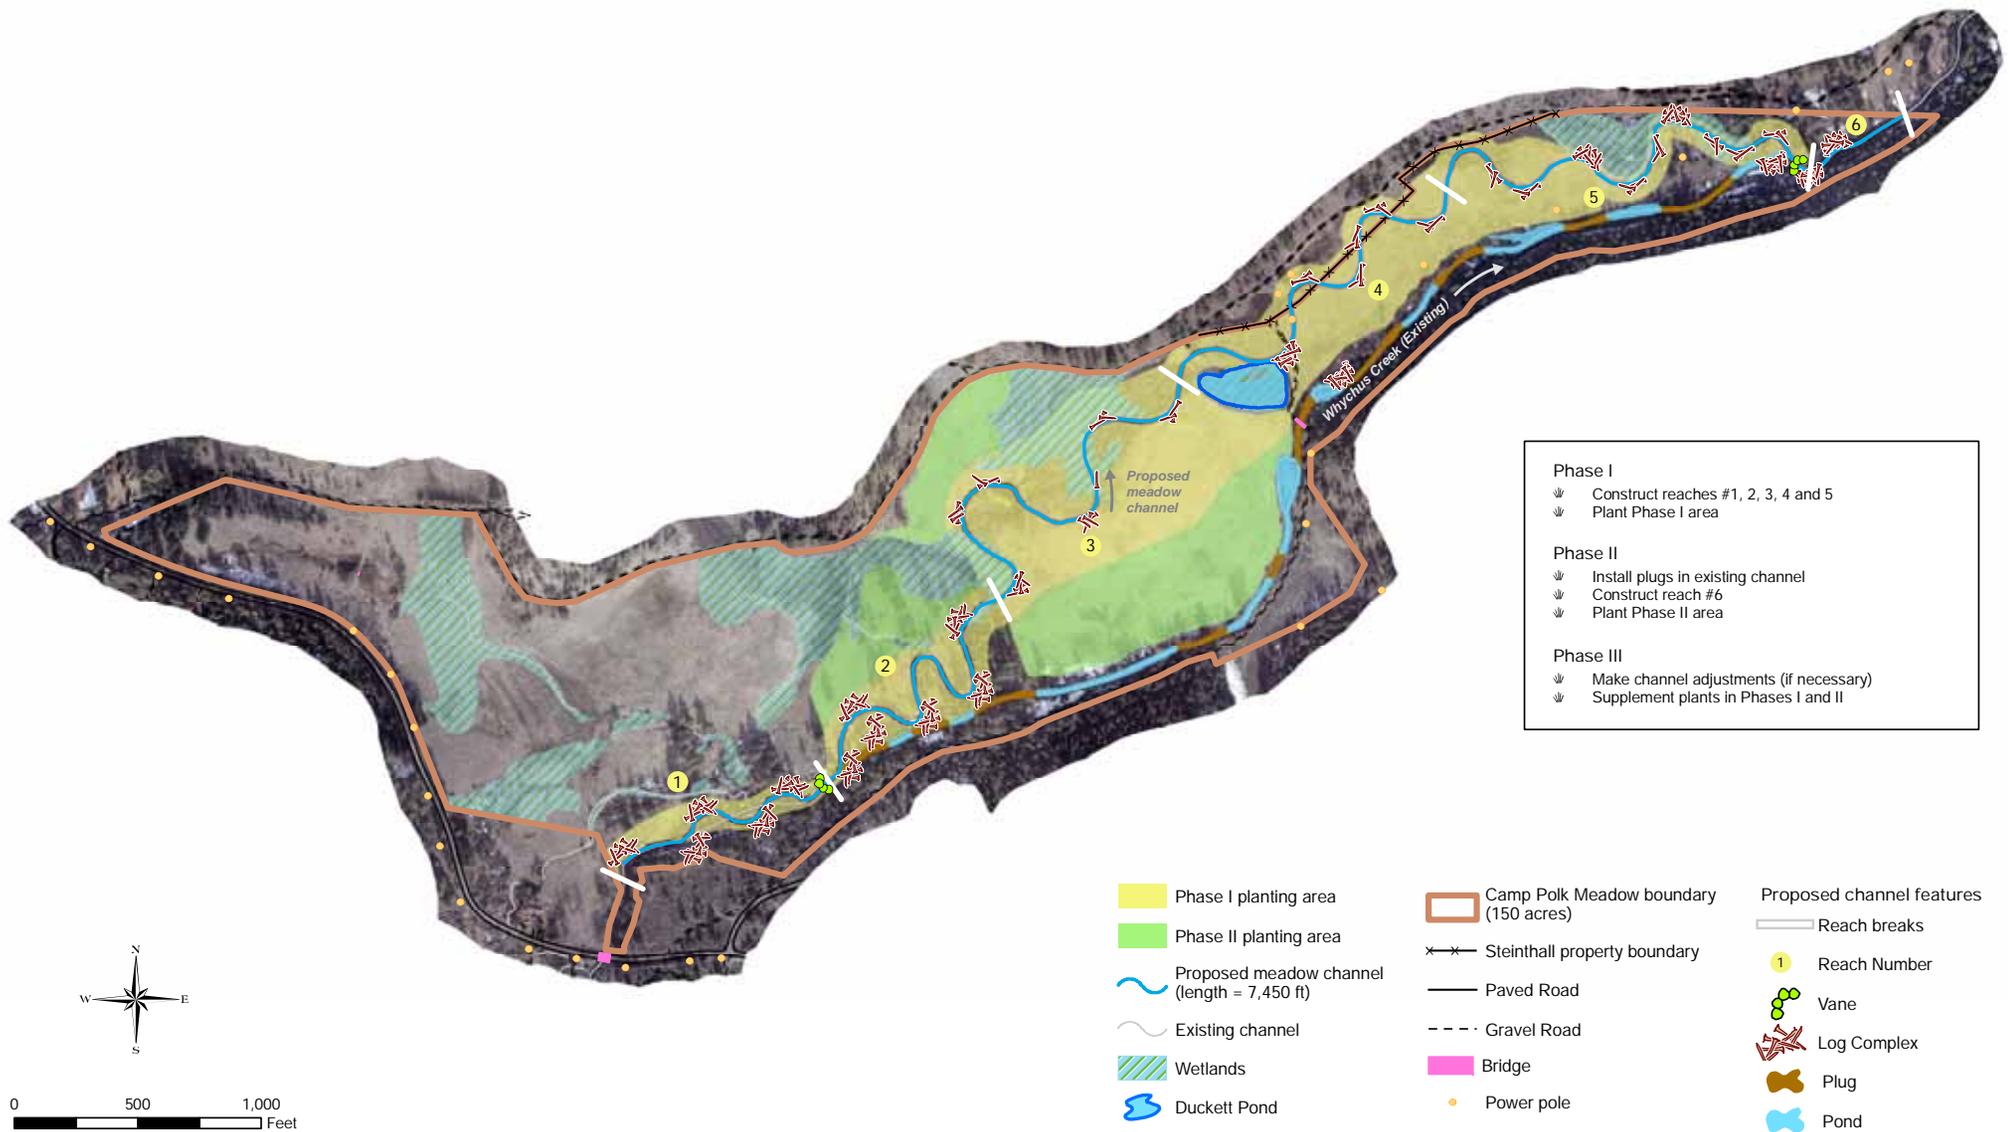
Figure 33. Project implementation phases.

The channel construction of this phase will take approximately two months to implement, with the planting adding an additional month. It is expected that summer months would be best for heavy equipment work (because the soil would be dry) and, based on past experience, fall and spring would be the best time to begin planting. Reach 1 instream work will need to occur during the instream work window of July 15 through October 15.

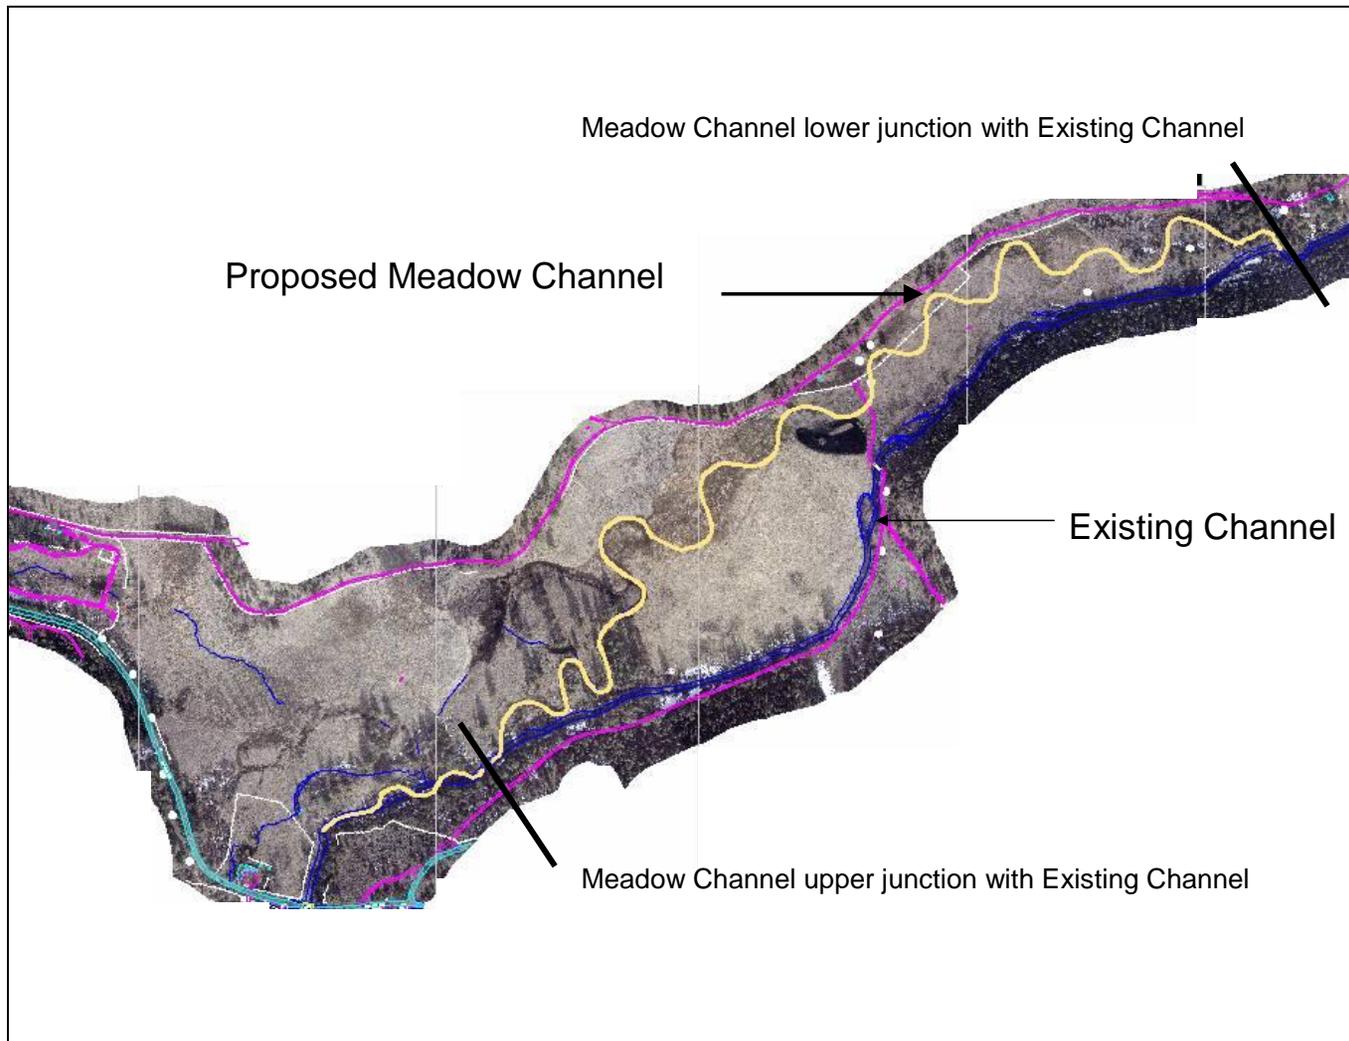
Figure A-1. Alternative comparison reaches for the Camp Polk Restoration Project shown by the black lines.

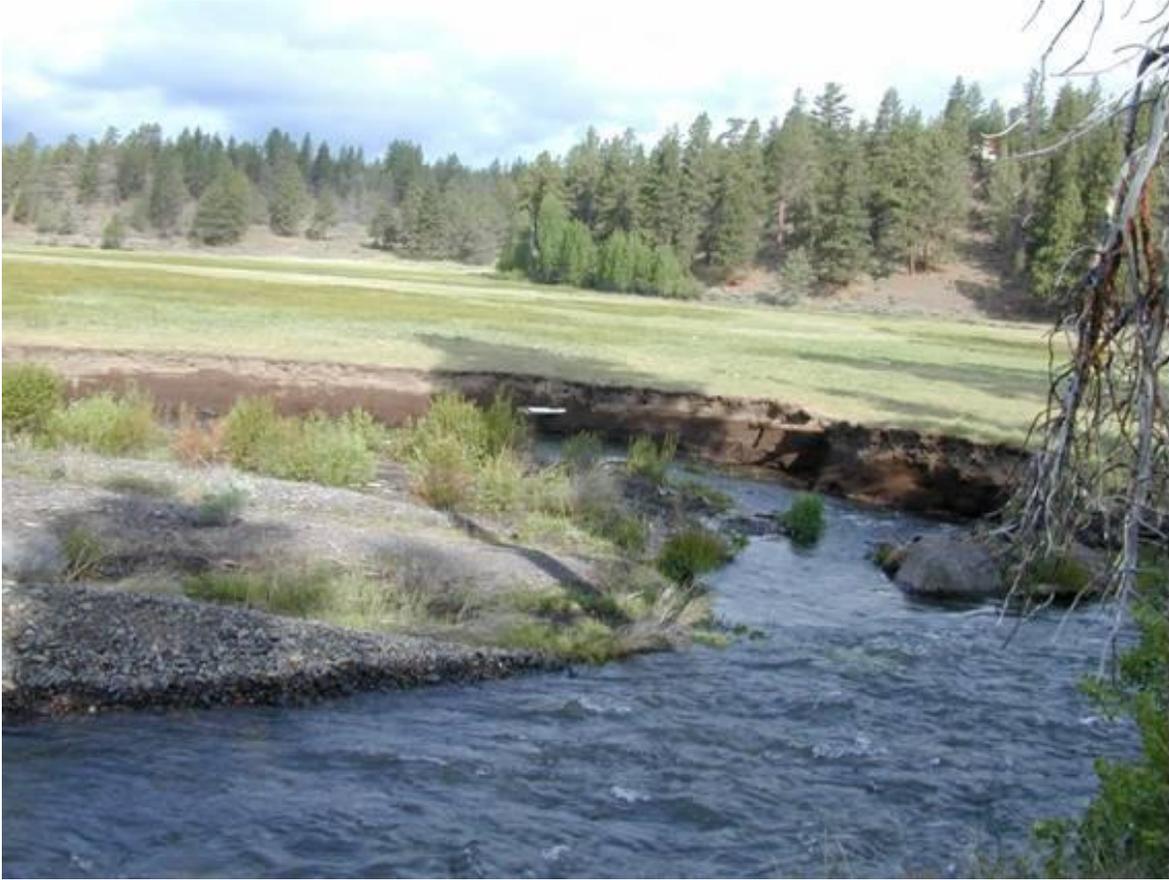
Figure A-2. Picture of sediment wedge and associated left bank channel erosion in Whychus Creek at Camp Polk meadows (2006).

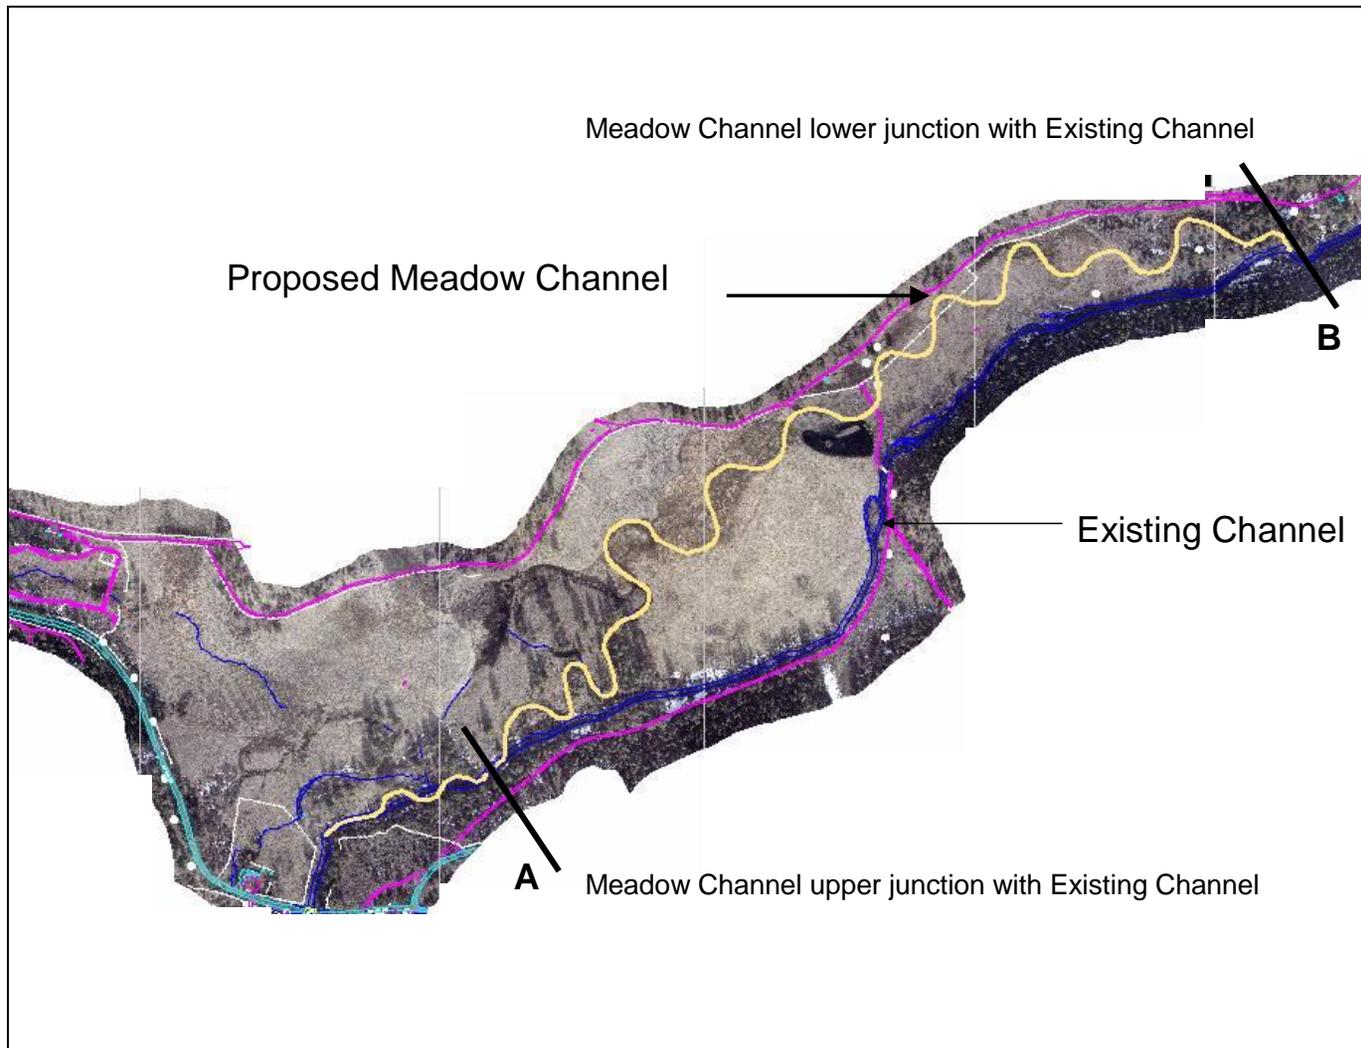
Figure 1. Map of proposed channel restoration and the upper (A) and lower (B) extent of the existing channel and the proposed meadow channel used for the habitat assessment.

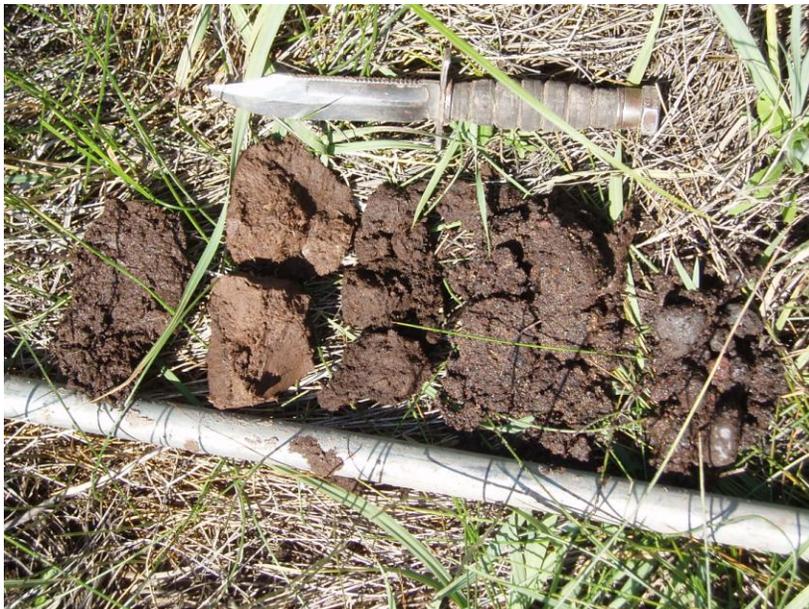
Figure C-1. Soil profile of Carex/Juncus relict channel site (left to right).

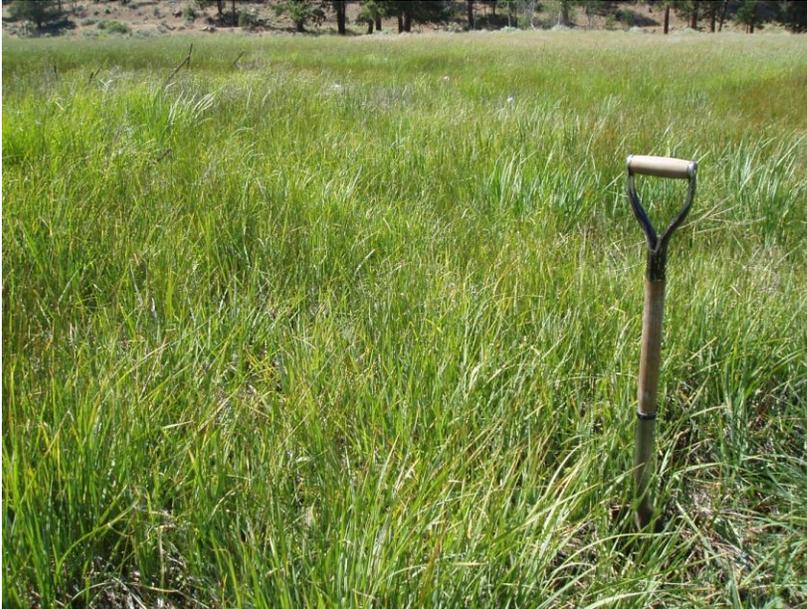
Figure C-2. Carex/Juncus wet meadow site in low lying 'relict' channel location.

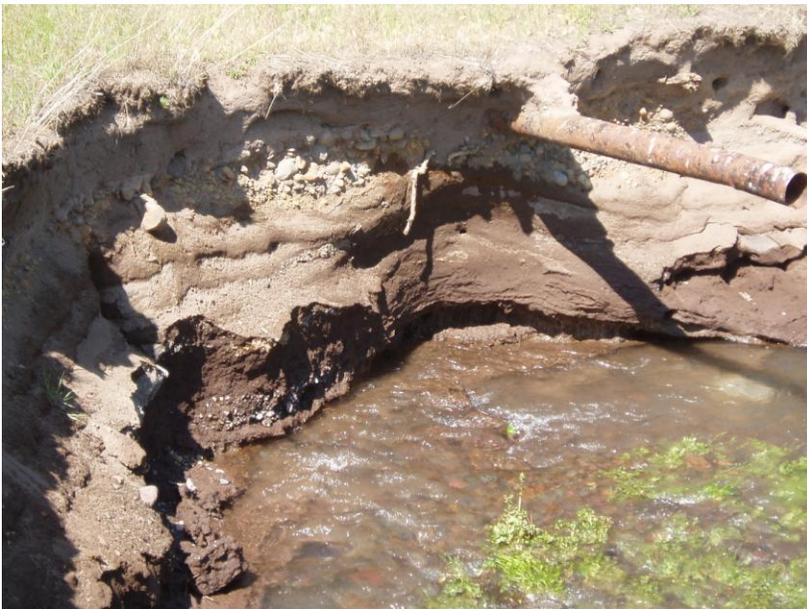
Figure C-3. Eastern meadow soil profile along Wychus Creek with historic drain.

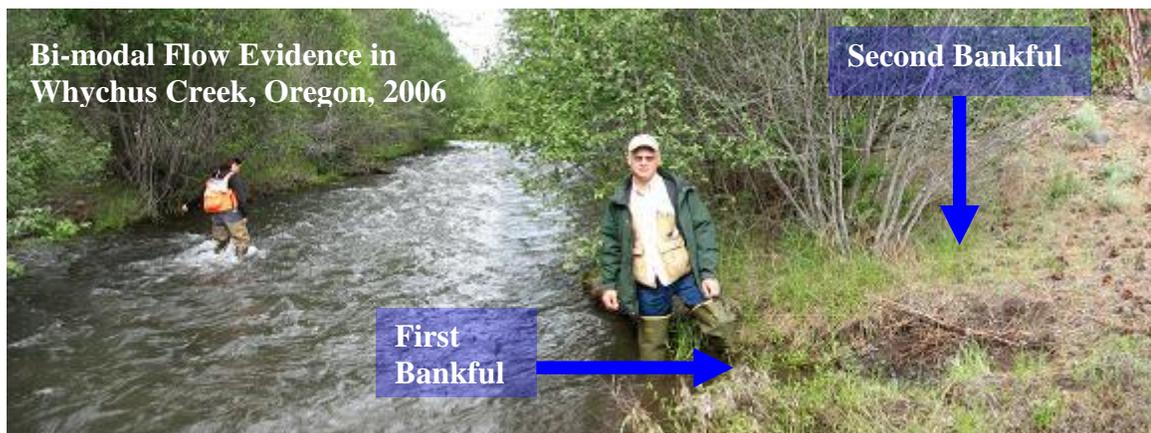
upstream of Camp Polk Meadow as evidenced by bi-modal bankful indicators seen in the photo below.

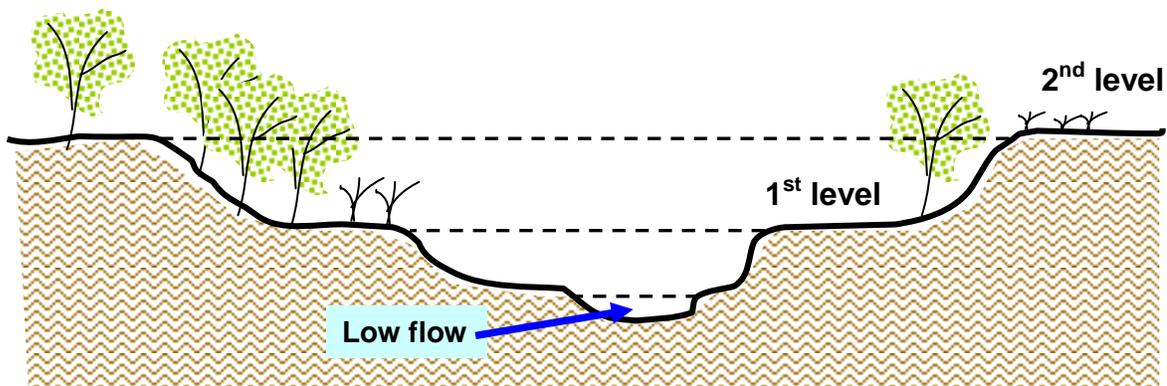
Conceptual drawing of a riffle cross section with multiple floodplain levels.

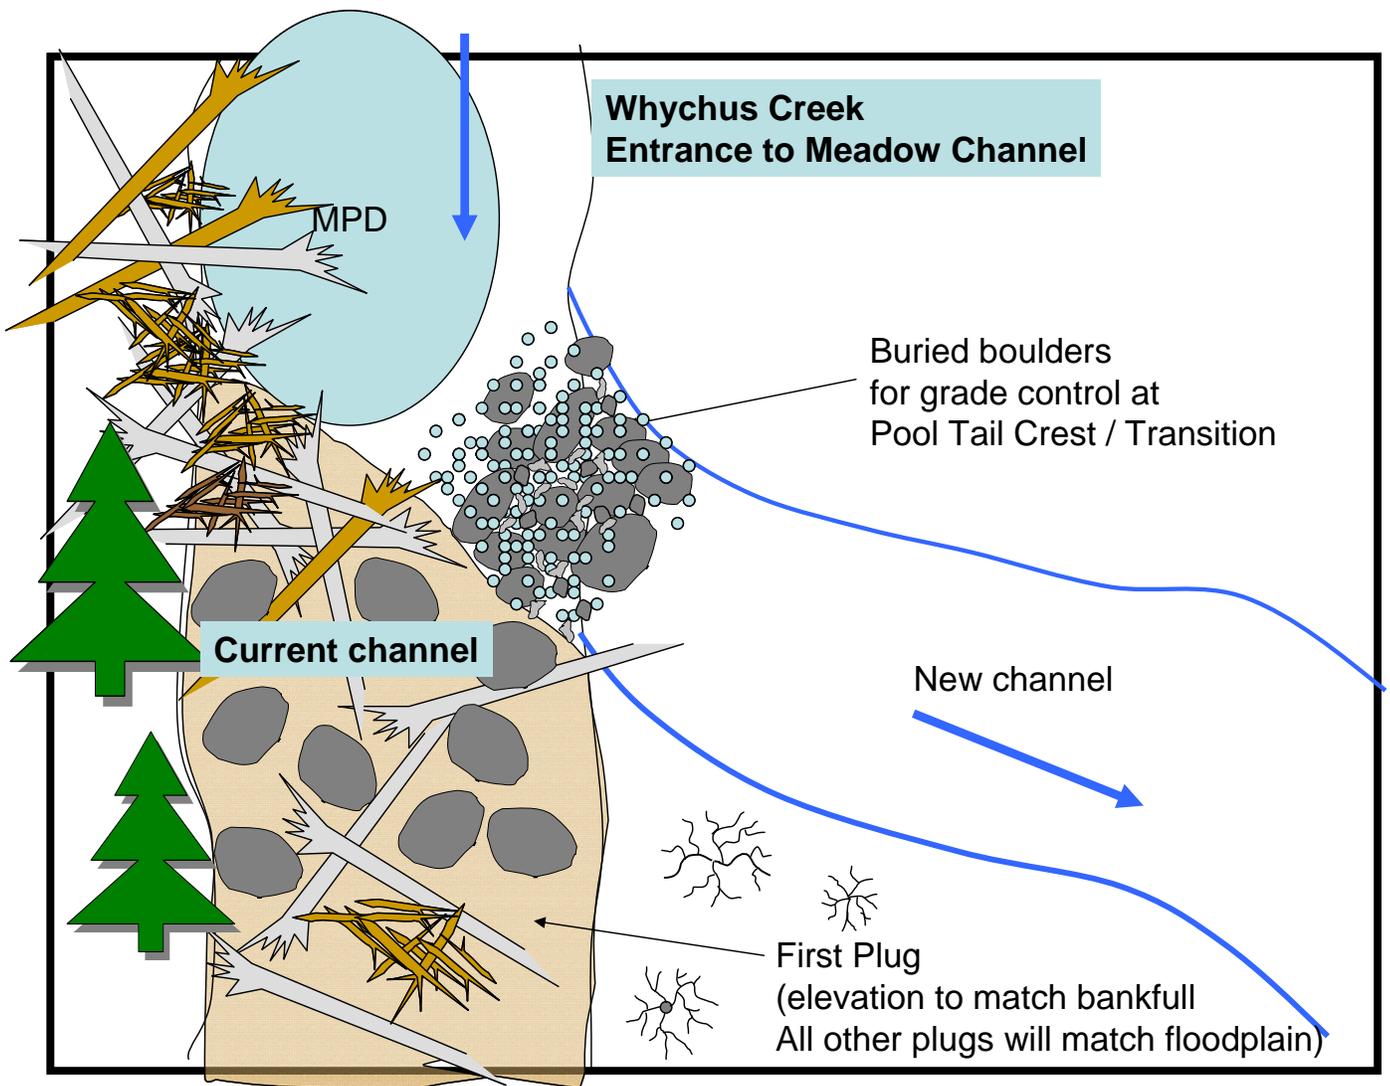
Figure G-2. Schematic of proposed entrance from the existing channel to the meadow channel at Camp Polk meadows.

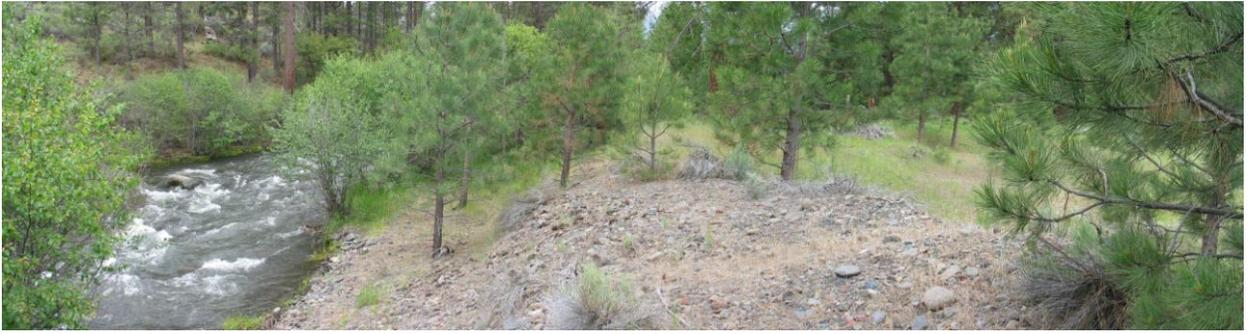
Figure G-3. View of current channel looking upstream from the proposed entrance to the meadow channel. Note the side cast pile of gravel on the river left bank.

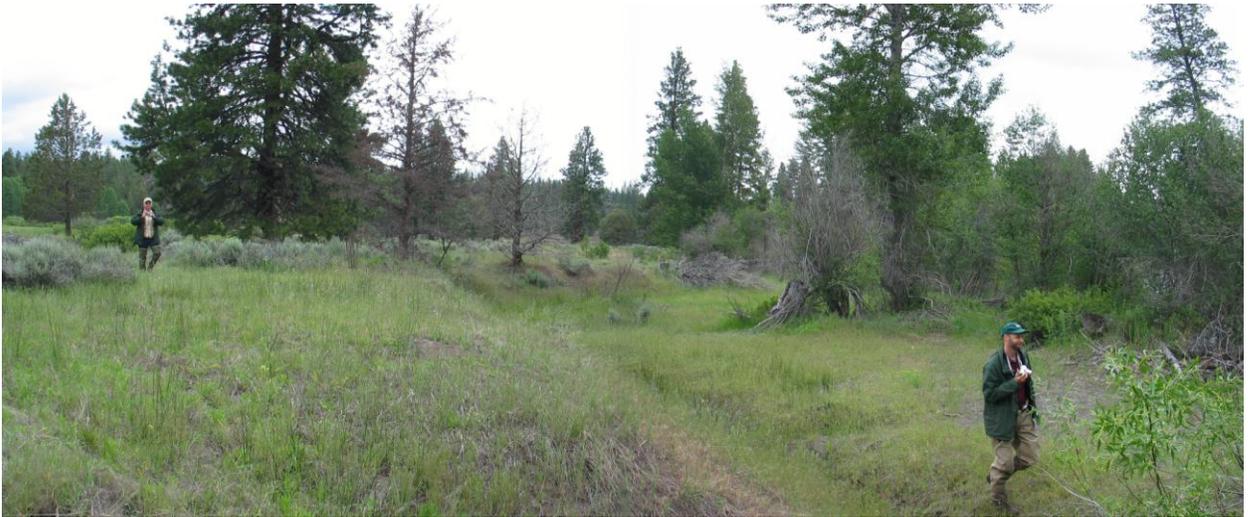
Figure G-4. View of relic meander looking down valley from the proposed entrance to the meadow channel.

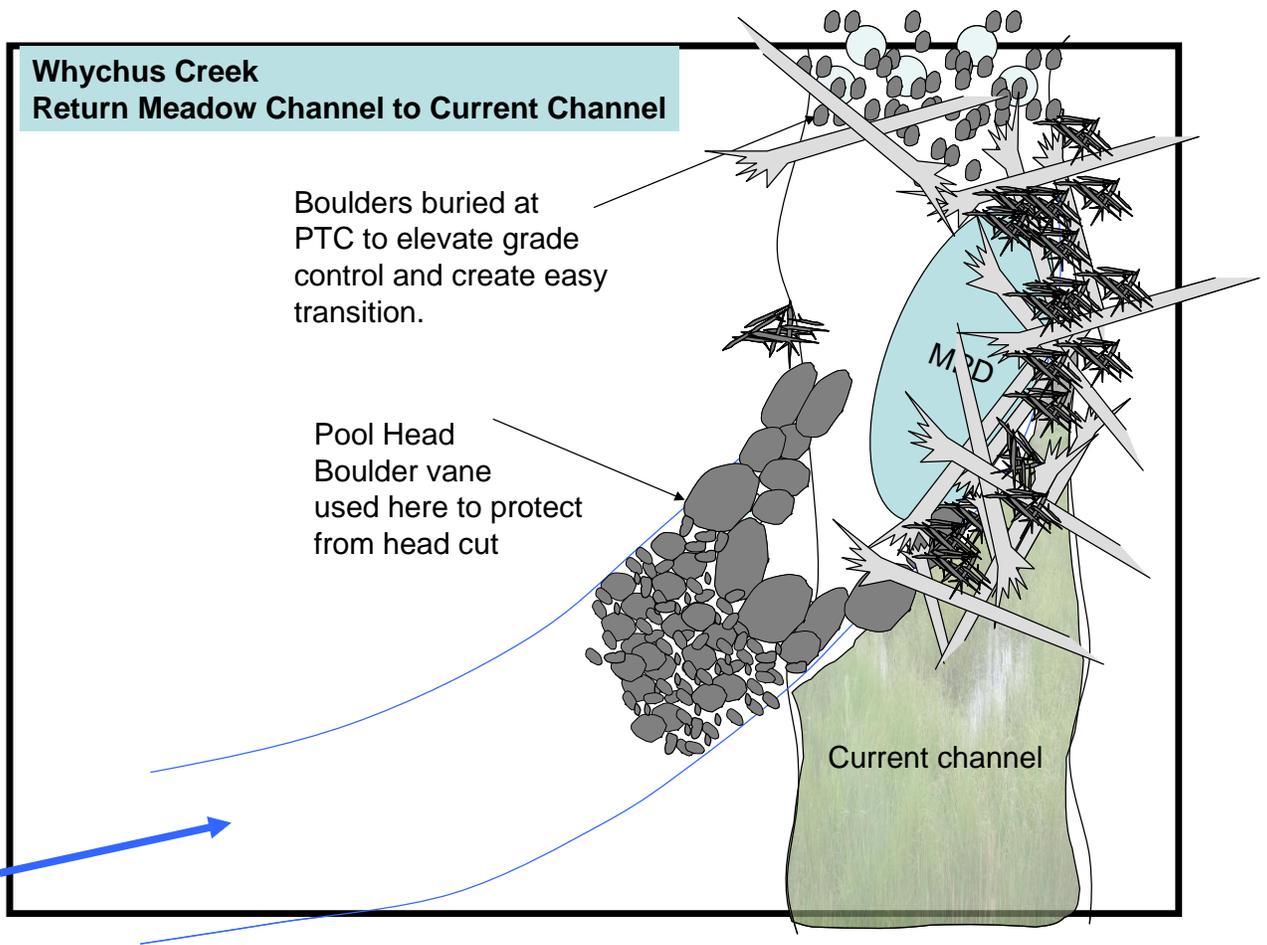
Figure G-5. Schematic of proposed exit from the meadow channel back into the existing channel at Camp Polk meadows.

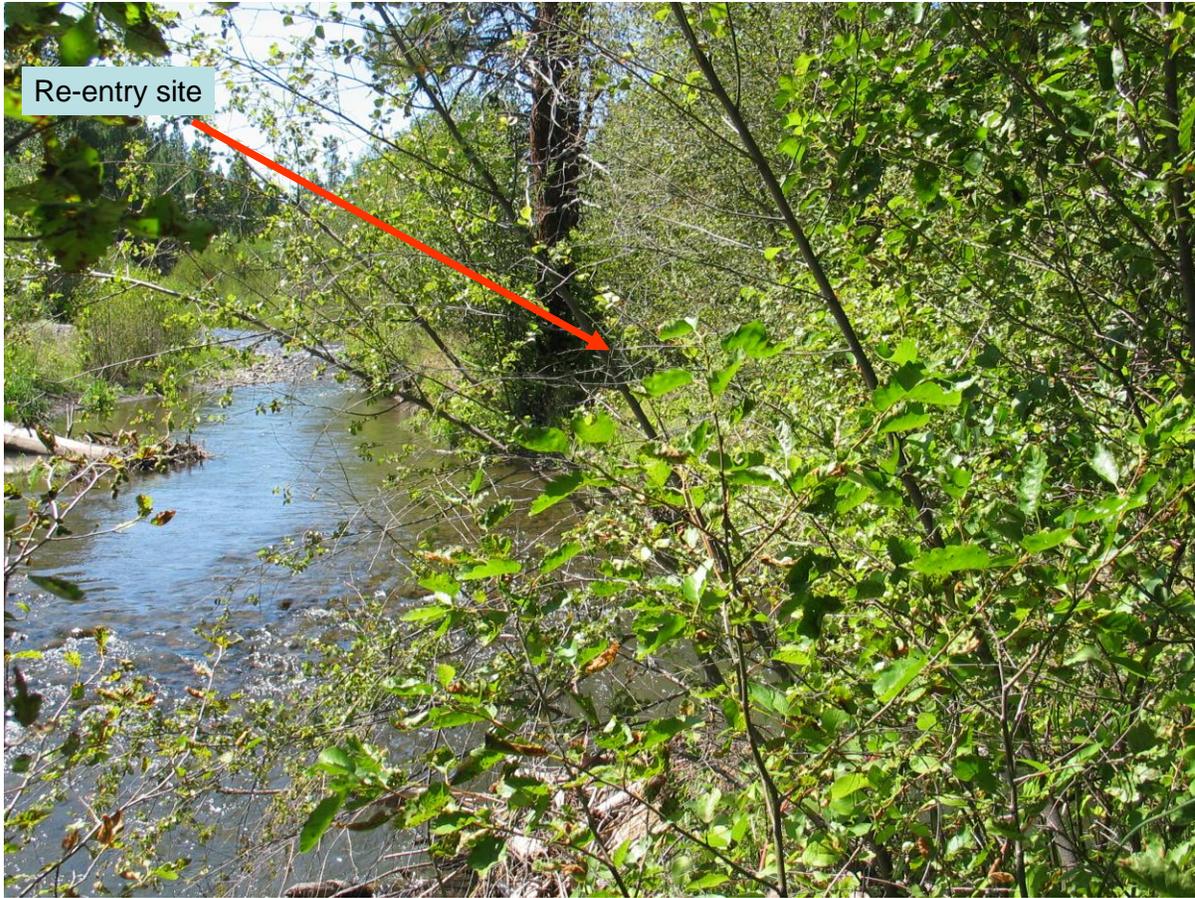
Figure G-6. View of current channel looking upstream from the location where the proposed meadow channel would reenter the existing channel. Note the existing vegetation that would provide important bank stability.

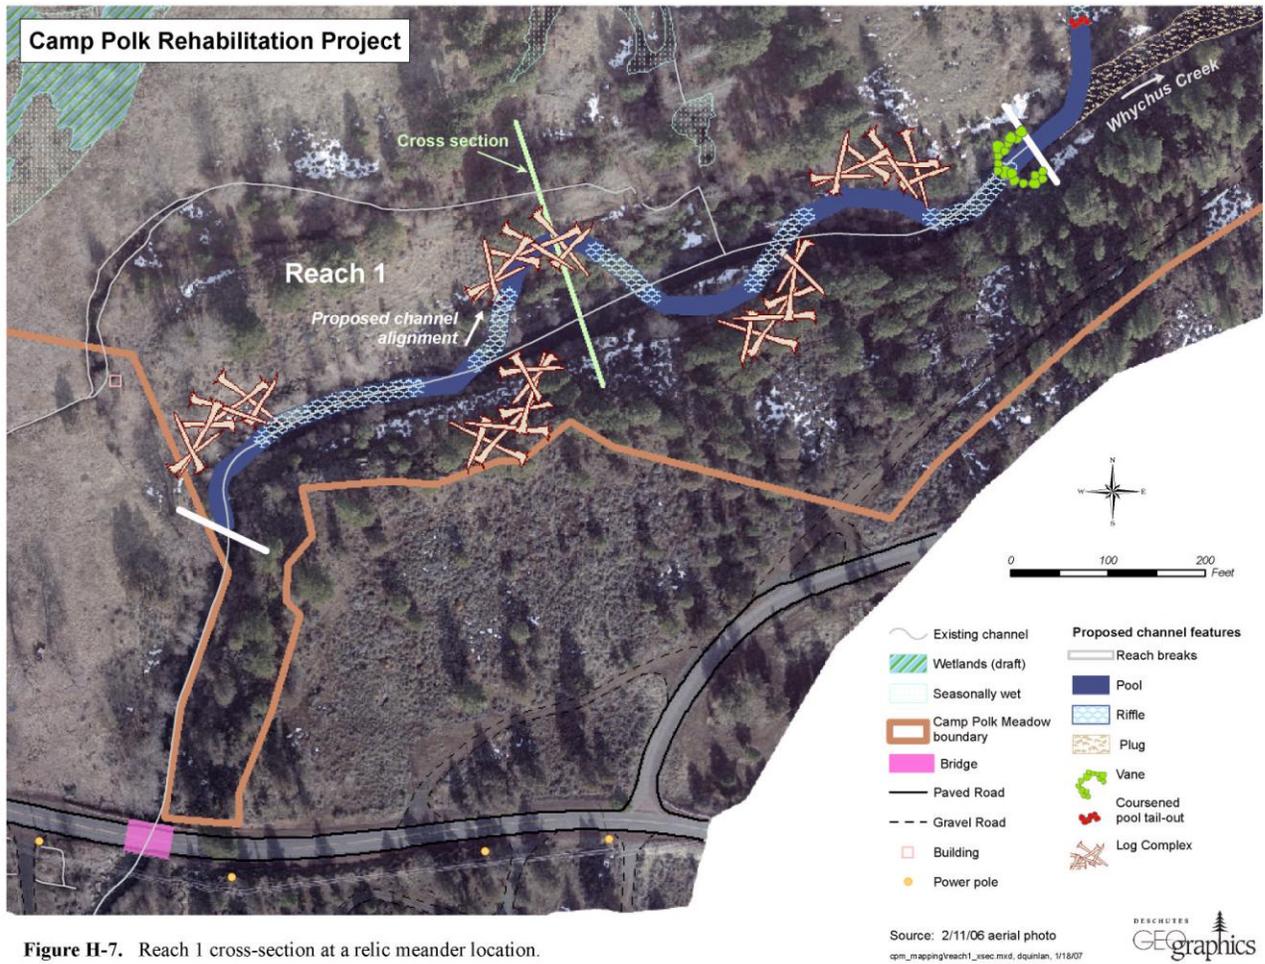
Figure H-7. Reach 1 cross-section at a relic meander location.

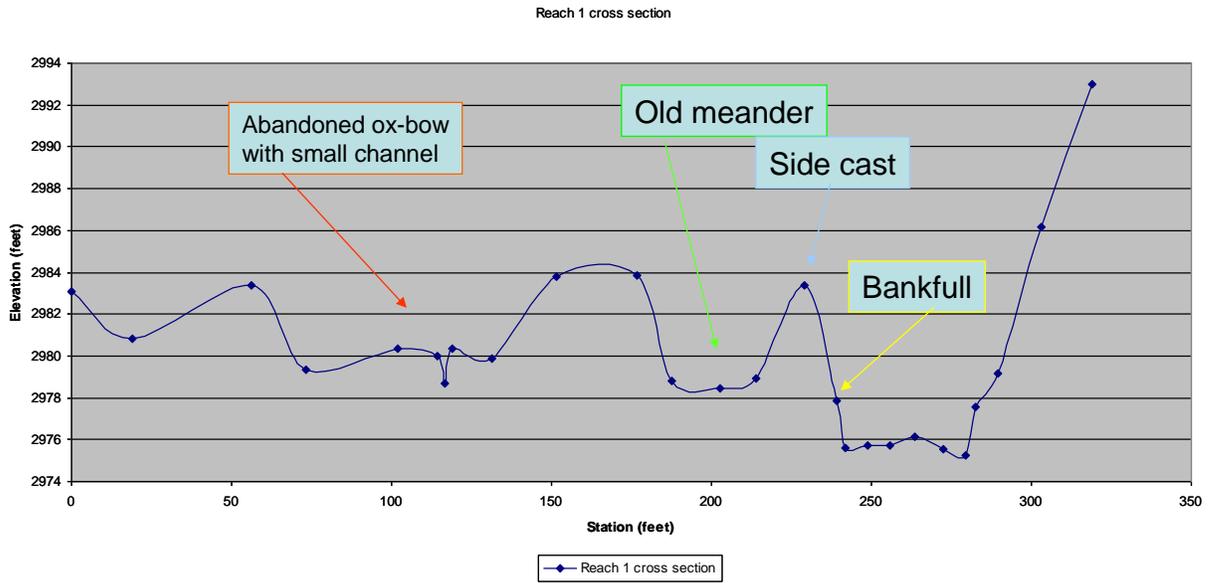
Figure G-8. Cross-section at a potential re-meander location in reach 1 of the Whychus Creek at Camp Polk.

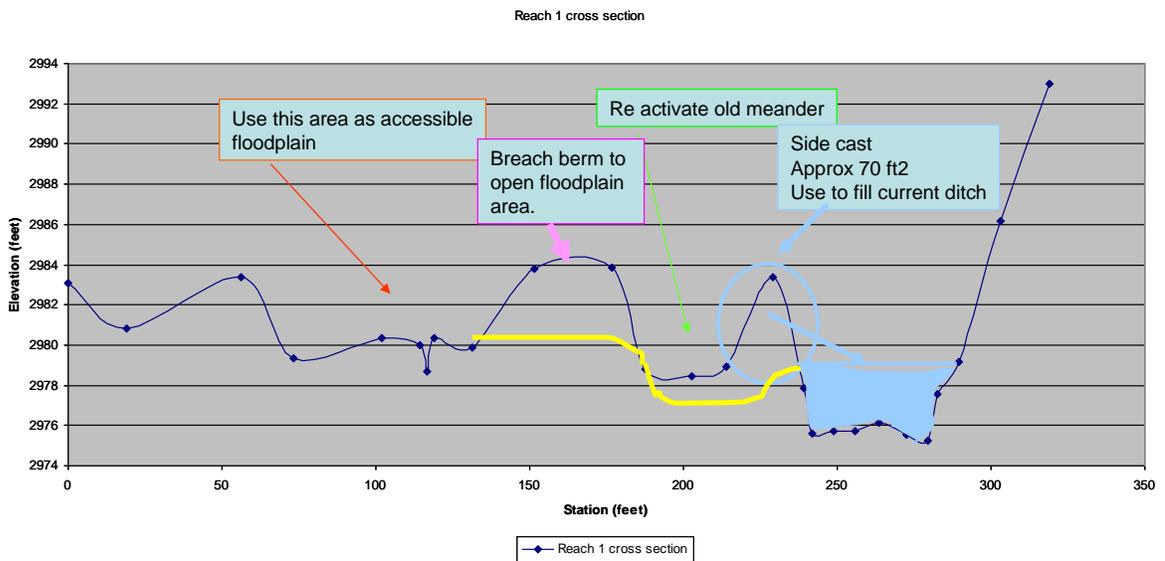
Figure G-9. Cross section showing how to create a meander in reach 1 of Whychus Creek at Camp Polk.
